## General Information

| Make | Toyota | Model | Vios |
| Registration No. | NHJ3364 | Chassis No. | PA1B18F36P4211233 |

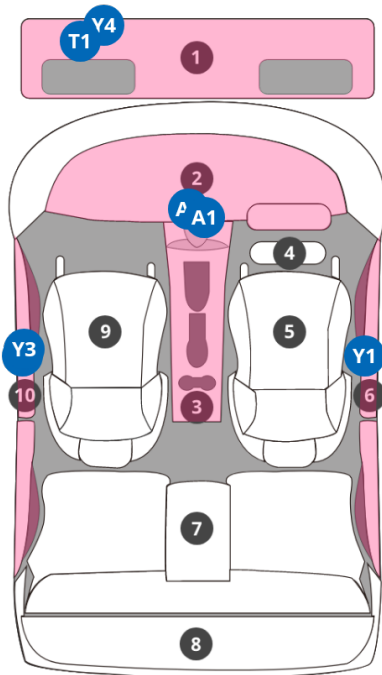
| Interior Evaluation : <b>C</b> | Exterior Evaluation : <b>D</b> |
|---|---|
| <p><b>Remarks</b></p> <p>(R) Front Trim - Grime - Minimal / (L) Front Trim - Worked - Small / (L) Front Trim - Grime - Medium / Ceiling - Grime - Large / Dashboard - Worn, Scratch, Cut, Crack - Minimal / Console, Switches, Vents - Worn, Scratch, Cut, Crack - Minimal / Ceiling - Cigarette Burns - Burnt Minimal</p> | <p><b>Remarks</b></p> <p>(L) Rear Door - Repair Traces - Yes / (L) Rear Fender - Repair Traces - Yes / (R) Front Fender, Molding - Scratch - Small / (R) Mirror - Scratch - Small / (L) Front Door, Molding - Repair mark - Yes / (R) Front Door, Molding - Scratch - Small / (R) Rear Door, Molding - Scratch - Minimal / (R) Step, In-panel, Side Spoiler - Dent - Small / (R) Rear Fender, Molding - Dent - Small / Rear Bumper, Lamps, Panels - Scratch &amp; Dent - Large / Trunk Hood, Rear Gate - Scratch &amp; Dent - Small / (L) Rear Fender, Molding - Scratch - Small / (L) Front Door, Molding - Scratch &amp; Dent - Small / (L) Rear Door, Molding - Scratch - Minimal / (L) Mirror - Scratch - Minimal / Member (Bolted) - Dent - Yes / (L) Front Fender, Molding - Scratch - Small / Front Bumper, Grille, Lamps - Scratch - Large</p> |
