## General Information

| Make | Suzuki | Model | Carry |
| Registration No. | NGQ9360 | Chassis No. | MHYDC61T6PJ211028 |

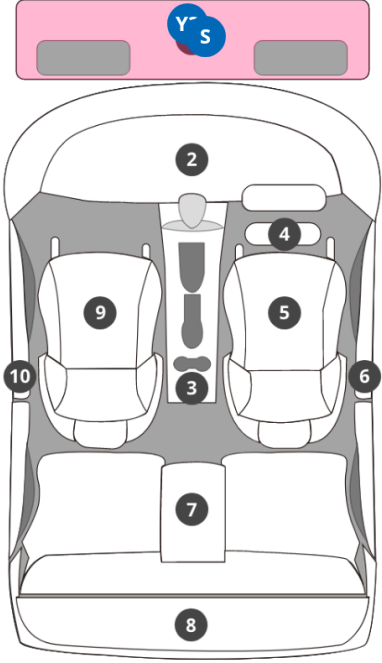
| Interior Evaluation : <b>B</b> | Exterior Evaluation : <b>D</b> |
| <b>Remarks</b><br>Ceiling - Grime - Medium / Overall Interior - Smell - Yes | <b>Remarks</b><br>(L) Rear Corner Panel - Repair Traces - Yes / (R) Rear Corner Panel - Repair Traces - Yes / (R) Front Door, Molding - Scratch - Minimal / (R) Side Gate - Scratch & Dent - Small / (R) Side Gate - Repair mark - Yes / Roof - Rust, Corrosion - Medium / Rear Bumper, Lamps, Panels - Scratch - Small / Rear Gate - Scratch - Small / (L) Side Gate - Repair mark - Yes / (L) Side Gate - Scratch - Medium / (L) Center Panel - Scratch - Minimal / (L) Front Door, Molding - Scratch - Small / Front Bumper, Grille, Lamps - Scratch - Small / Front Panel - Scratch - Minimal / (R) Front Fender, Molding - Scratch - Minimal / (L) Front Fender, Molding - Scratch - Minimal / Cargo Bed Floor - Scratch - Large |
