## General Information

| Make | Toyota | Model | Lite Ace |
| Registration No. | NHS6784 | Chassis No. | MHKU3FE10RK008236 |

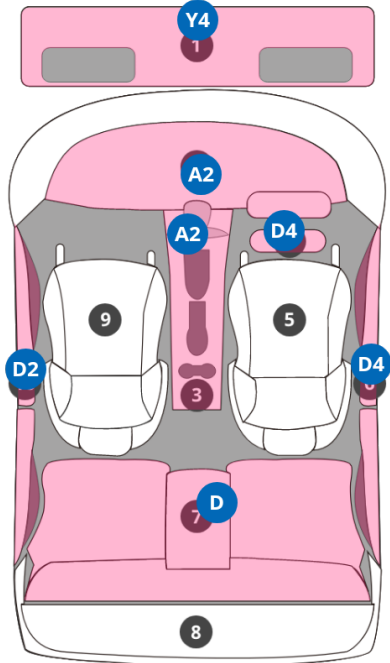
| Interior Evaluation : <span style="color: red;">C</span> | Exterior Evaluation : <span style="color: red;">E</span> |
| <b>Remarks</b><br>(R) Front Trim - Worked - Large / Ceiling - Grime - Large / Rear Seat - Worn - Yes / Dashboard - Worn, Scratch, Cut, Crack - Small / Console, Switchs, Vents - Worn, Scratch, Cut, Crack - Small / (L) Front Trim - Worked - Small / (L) Front Floor Mat - Worked - Large | <b>Remarks</b><br>(R) Front Door - Repair Traces - Yes / (L) Rear Corner Panel - Repair Traces - Yes / (R) Center Panel - Repair Traces - Yes / (R) Mirror - Crack - Damaged / (R) Front Fender, Molding - Repair mark - Yes / (R) Front Fender, Molding - Dent - Large / (R) Front Door, Molding - Repair mark - Yes / (R) Front Door, Molding - Scratch - Medium / (R) Center Panel - Repair mark - Yes / (R) Center Panel - Dent - Small / Overall Exterior - Re-Paint Uneven - Yes / (R) Side Gate - Scratch & Dent - Large / Rear Bumper, Lamps, Panels - Dent - Medium / Rear Gate - Modified - Medium / (L) Side Gate - Scratch - Medium / (L) Front Door, Molding - Scratch - Large / (L) Front Door, Molding - Repair mark - Yes / Roof - Dent - Large / Cargo Bed Floor - Scratch - Large / Cab Back Panel - Rust, Corrosion - Large / Front Bumper, Grille, Lamps - Scratch & Dent - Large / Front Panel - Dent - Large / (L) Front Fender, Molding - Scratch - Small / Front Windshield - Damaged - Large |
