## General Information

| Make | Toyota | Model | Lite Ace |
| Registration No. | NID6570 | Chassis No. | MHKU3FE10NK000545 |

## Body / Panel Condition

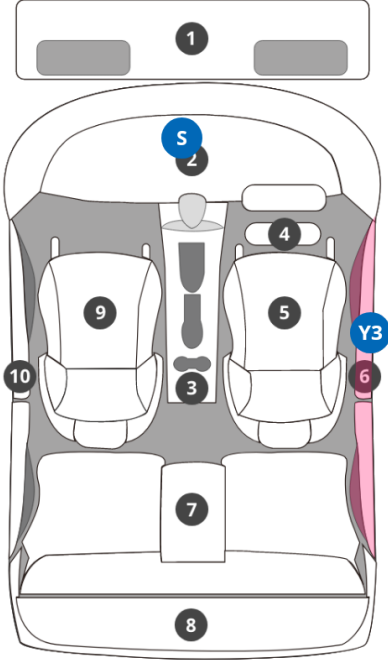
| Interior Evaluation : <span style="color: red;">C</span> | Exterior Evaluation : <span style="color: red;">E</span> |
| <b>Remarks</b><br>Overall Interior - Worn as per age - Yes / Overall Interior - Smell - Yes / (R) Front Trim - Grime - Medium | <b>Remarks</b><br>(R) Side Gate - Rust, Corrosion - Large / (L) Side Gate - Rust, Corrosion - Large / Cargo Bed Floor - Rust, Corrosion - Large / (R) Front Door, Molding - Scratch - Small / (R) Center Panel - Scratch - Small / (R) Step, In-panel, Side Spoiler - Scratch - Medium / Rear Gate - Rust, Corrosion - Large / Cab Back Panel - Rust, Corrosion - Large / Rear Bumper, Lamps, Panels - Rust, Corrosion - Medium / (L) Center Panel - Scratch & Dent - Medium / (L) Front Door, Molding - Scratch & Dent - Medium / (L) Mirror - Scratch - Minimal / (R) Front Fender, Molding - Scratch - Small / Front Panel - Scratch - Minimal / Front Bumper, Grille, Lamps - Scratch - Medium / Roof - Rust, Corrosion - Large / Rear Bumper, Lamps, Panels - Modified - Medium |
