## General Information

| Make | Toyota | Model | Vios |
| Registration No. | DBR4470 | Chassis No. | PA1B18F37R4275252 |

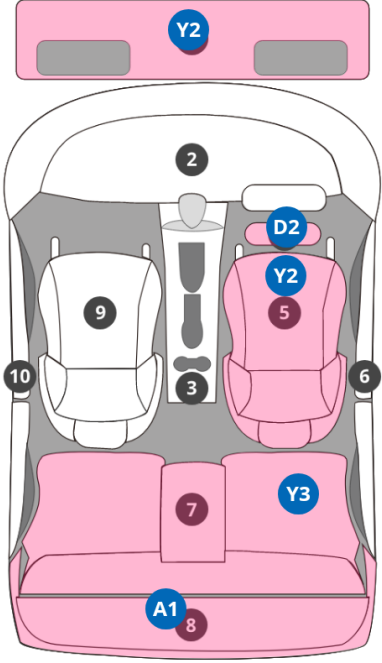
| Interior Evaluation : <b>B</b> | Exterior Evaluation : <b>D</b> |
|---|---|
| <p><b>Remarks</b></p> <p>Trunk Room - Worn, Scratch, Cut, Crack - Minimal / (R)<br/>Front Seat - Grime - Small / Rear Seat - Grime - Medium<br/>/ Ceiling - Grime - Small / (L) Front Floor Mat - Worked - Small</p> | <p><b>Remarks</b></p> <p>(R) Front Fender, Molding - Scratch - Small / (R) Front Door, Molding - Scratch - Large / (R) Rear Door, Molding - Scratch - Large / (R) Rear Fender, Molding - Scratch &amp; Dent - Large / Rear Bumper, Lamps, Panels - Scratch - Small / Trunk Hood, Rear Gate - Scratch - Small / (L) Rear Fender, Molding - Scratch - Medium / (L) Rear Door, Molding - Scratch - Minimal / Member (Bolted) - Dent - Yes / Front Bumper, Grille, Lamps - Scratch &amp; Dent - Small / Roof - Scratch - Minimal</p> |

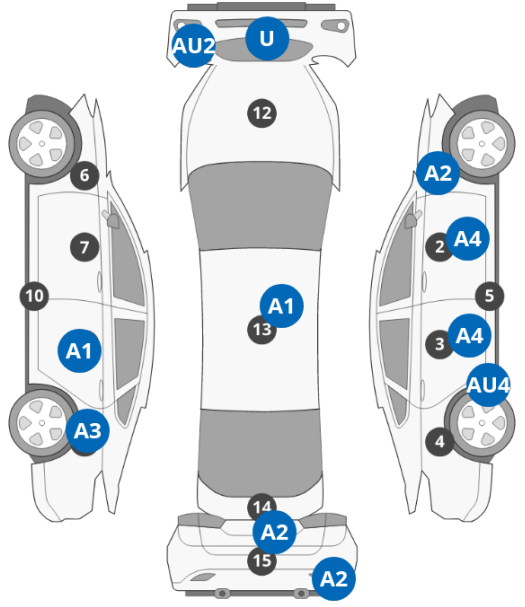
| Inspector Notes |
|---|
| with LTO plate, with warranty booklet, with jack, incomplete tools, with spare tire, cracked tail lights |
