## General Information

| Make | Toyota | Model | Vios |
| Registration No. | EAE4895 | Chassis No. | PA1B18F39M4157034 |

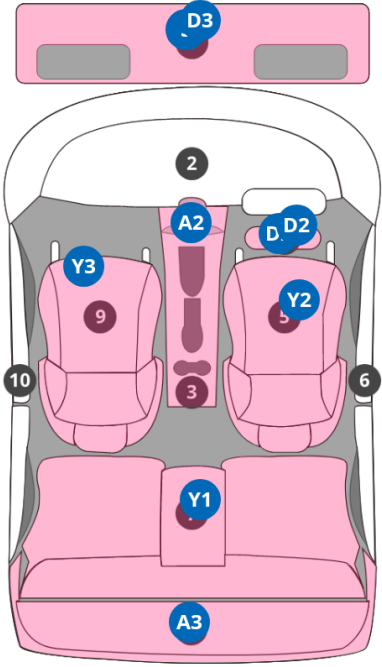
| Interior Evaluation : <b>C</b> | Exterior Evaluation : <b>E</b> |
|---|---|
| <p><b>Remarks</b></p> <p>Trunk Room - Worn, Scratch, Cut, Crack - Medium / Overall Interior - Smell - Yes / Ceiling - Crinkle - Medium / (L) Front Floor Mat - Worked - Small / (R) Front Floor Mat - Worked - Small / (L) Front Seat - Grime - Medium / Overall Interior - Worn as per age - Yes / Rear Seat - Grime - Minimal / (R) Front Seat - Grime - Small / Console, Switches, Vents - Worn, Scratch, Cut, Crack - Small</p> | <p><b>Remarks</b></p> <p>(L) Rear Door - Repair Traces - Yes / (R) Front Fender, Molding - Scratch &amp; Dent - Minimal / (R) Mirror - Scratch - Minimal / (R) Front Door, Molding - Scratch - Minimal / (R) Rear Door, Molding - Scratch - Minimal / (R) Rear Fender, Molding - Scratch &amp; Dent - Small / Rear Bumper, Lamps, Panels - Scratch - Medium / Trunk Hood, Rear Gate - Scratch - Small / (L) Rear Fender, Molding - Scratch - Medium / (L) Rear Door, Molding - Repair mark - Yes / (L) Rear Door, Molding - Scratch - Medium / (L) Step, In-panel, Side Spoiler - Scratch &amp; Dent - Small / (L) Front Door, Molding - Dent - Medium / Roof - Dent - Medium / (L) Mirror - Crack - Damaged / (L) Front Fender, Molding - Scratch - Small / Front Bumper, Grille, Lamps - Scratch &amp; Dent - Medium / Bonnet, Headlight - Scratch - Small</p> |
