## General Information

| Make | Toyota | Model | Innova |
| Registration No. | NHA2703 | Chassis No. | PA2JA8EM8P0127245 |

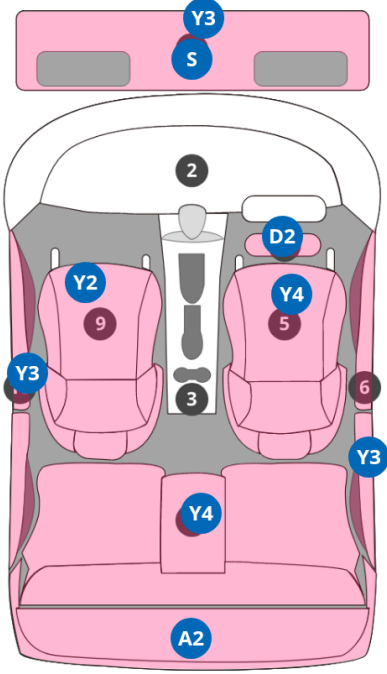
| Interior Evaluation : <span style="color: red;">C</span> | Exterior Evaluation : <span style="color: red;">E</span> |
| <b>Remarks</b><br>(R) Front Seat - Grime - Large / Rear Seat - Grime - Large / Ceiling - Grime - Medium / (R) Rear Trim - Grime - Medium / Trunk Room - Worn, Scratch, Cut, Crack - Small / (L) Front Trim - Grime - Medium / (L) Front Seat - Grime - Small / Overall Interior - Smell - Yes / Overall Interior - Worn as per age - Yes / (L) Front Floor Mat - Worked - Small | <b>Remarks</b><br>Trunk Hood, Rear Gate - Repair Traces - Yes / (R) Front Fender, Molding - Scratch & Dent - Small / (R) Front Door, Molding - Scratch - Small / (R) Mirror - Scratch - Small / (R) Rear Door, Molding - Scratch & Dent - Small / (R) Step, In-panel, Side Spoiler - Scratch & Dent - Small / (R) Rear Fender, Molding - Scratch - Small / Trunk Hood, Rear Gate - Repair mark - Yes / Rear Bumper, Lamps, Panels - Scratch - Large / Trunk Hood, Rear Gate - Scratch - Small / (L) Rear Fender, Molding - Scratch & Dent - Minimal / Roof - Scratch & Dent - Small / (L) Mirror - Scratch - Minimal / (L) Rear Door, Molding - Scratch - Small / (L) Front Door, Molding - Scratch - Medium / (L) Front Fender, Molding - Scratch - Small / Front Bumper, Grille, Lamps - Scratch - Medium / Bonnet, Headlight - Scratch - Small |

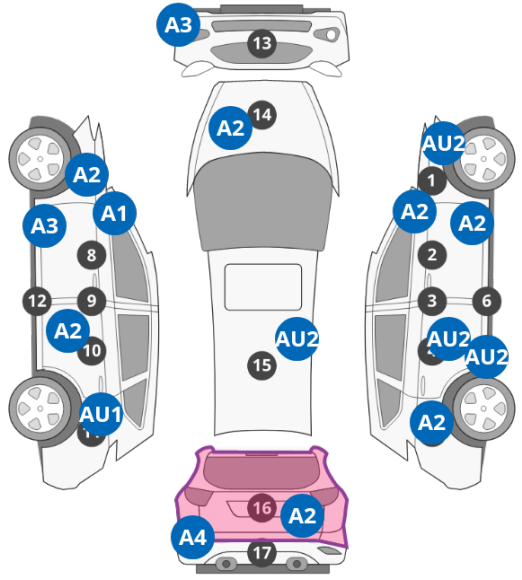
| Inspector Notes |
|---|
| with LTO plate, with warranty booklet, with jack and tools, with spare tire, cracked tail light, tail light issue, possible flooded |
