## General Information

| Make | Toyota | Model | Lite Ace |
| Registration No. | DBO4360 | Chassis No. | MHKU3FE10PK005724 |

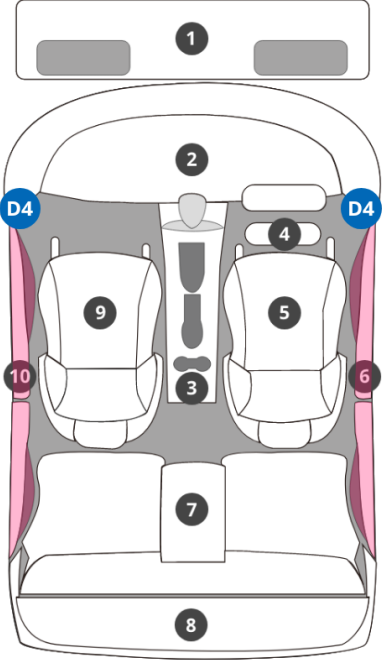
| <b>Remarks</b><br>Trim Other - Worked - Large / Trim Other - Worked - Large | <b>Remarks</b><br>(R) Front Door, Molding - Scratch - Small / (R) Center Panel - Scratch - Small / (R) Side Gate - Scratch - Medium / Rear Gate - Scratch - Large / (L) Side Gate - Scratch - Medium / Cargo Bed Floor - Scratch & Dent - Large / Cab Back Panel - Scratch - Large / (L) Center Panel - Scratch - Medium / (L) Front Door, Molding - Scratch - Minimal / Front Panel - Scratch - Small / Roof - Dent - Medium |
