## General Information

| Make | Toyota | Model | Vios |
| YOM | 2020 | Odo Meter Reading | 55,821 |
| Registration No. | NGD6936 | Chassis No. | PA1B18F32L4115870 |

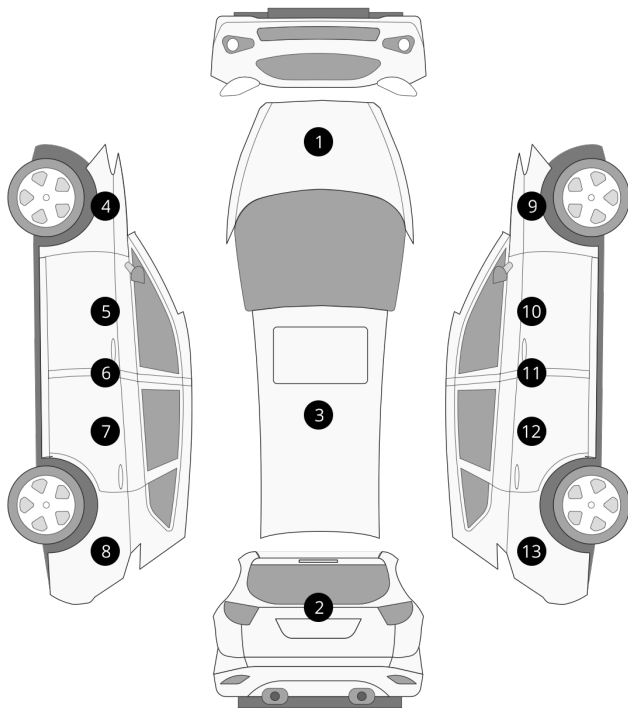
## Body / Panel Condition

| # | Area | Thickness(um) | | | |
| 1 | Bonnet | 185.6 | 192 | 184 | 181 |
| 2 | Boot Lid | 186.6 | 190 | 183 | 187 |
| 3 | Roof | 183.5 | 179 | 182 | 190/183 |
| 4 | Left Front Fender | 184.6 | 181 | 182 | 191 |
| 5 | Left Front Door | 187.3 | 191 | 181 | 190 |
| 7 | Left Rear Door | 188.0 | 184 | 188 | 192 |
| 8 | Left Back Panel | 179.0 | 180 | 188 | 169 |
| 9 | Right Front Fender | 189.0 | 192 | 183 | 192 |
| 10 | Right Front Door | 188.0 | 180 | 180 | 204 |
| 12 | Right Rear Door | 177.3 | 166 | 187 | 179 |
| 13 | Right Back Panel | 188.3 | 191 | 182 | 192 |

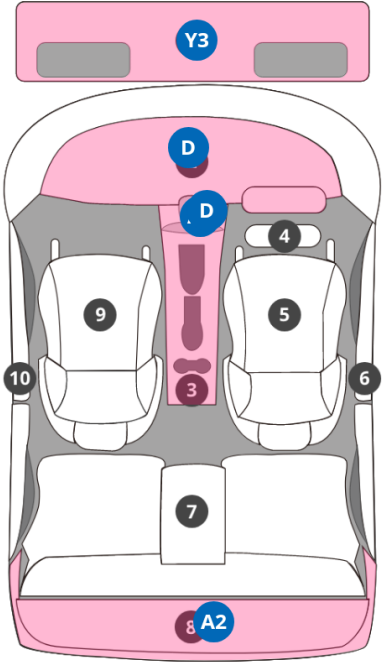
| Interior Evaluation : <b>C</b> | Exterior Evaluation : <b>E</b> |
|---|---|
| <p><b>Remarks</b></p> <p>Trunk Room - Worn, Scratch, Cut, Crack - Small / Ceiling - Grime - Medium / Console, Switchs, Vents - Worn, Scratch, Cut, Crack - Medium / Console, Switchs, Vents - Traces of Adhesive Tape - Yes / Overall Interior - Worn as per age - Yes / Dashboard - Traces of Adhesive Tape - Yes</p> | <p><b>Remarks</b></p> <p>(R) Front Door - Repair Traces - Yes / (R) Front Fender - Repair Traces - Yes / Bonnet - Repair Traces - Yes / (L) Front Fender - Repair Traces - Yes / (L) Front Door - Repair Traces - Yes / (L) Rear Door - Repair Traces - Yes / (L) Rear Fender - Repair Traces - Yes / Trunk Hood, Rear Gate - Repair Traces - Yes / (R) Rear Fender - Repair Traces - Yes / (R) Rear Door - Repair Traces - Yes / Roof - Repair Traces - Yes / Overall Exterior - Full Re-Paint in same color - Yes / Member (Bolted) - Dent - Yes / (R) Front Fender, Molding - Dent - Large / (R) Front Wheel, Cover - Scratch, Corrosion - Small / (R) Rear Wheel, Cover - Scratch, Corrosion - Small / (R) Mirror - Crack - Damaged / (R) Front Door, Molding - Scratch - Minimal / (R) Rear Door, Molding - Scratch - Small / (R) Rear Fender, Molding - Scratch - Minimal / Rear Bumper, Lamps, Panels - Scratch - Medium / Trunk Hood, Rear Gate - Scratch &amp; Dent - Small / (L) Rear Fender, Molding - Scratch - Small / (L) Rear Door, Molding - Scratch &amp; Dent - Small / (L) Front Door, Molding - Scratch - Small / (L) Mirror - Scratch - Small / (L) Front Fender, Molding - Scratch &amp; Dent - Small / Front Bumper, Grille, Lamps - Scratch - Large / Roof - Scratch - Minimal / Bonnet, Headlight - Scratch - Minimal</p> |
