## General Information

| Make | Suzuki | Model | APV |
| Registration No. | NGF4667 | Chassis No. | MHYDN71V0LJ402617 |

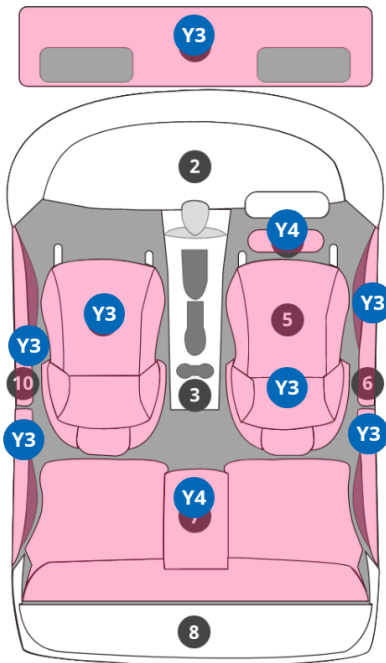
| Interior Evaluation :<br>E | Exterior Evaluation :<br>C |
| <div>Remarks</div> <div>Ceiling - Grime - Medium / (R) Front Seat - Grime - Medium / Rear Seat - Grime - Large / Mat Other - Grime - Large / (R) Rear Trim - Grime - Medium / (R) Front Trim - Grime - Medium / (L) Rear Trim - Grime - Medium / (L) Front Trim - Grime - Medium / (L) Front Seat - Grime - Medium</div> | <div>Remarks</div> <div>(L) Front Door - Repair Traces - Yes / (L) Rear Door - Repair Traces - Yes / (L) Rear Fender - Repair Traces - Yes / Trunk Hood, Rear Gate - Repair Traces - Yes / (L) Rear Fender, Molding - Scratch &amp; Dent - Small / (L) Mirror - Scratch - Minimal / (R) Mirror - Scratch - Small / (R) Rear Door, Molding - Scratch &amp; Dent - Small / (R) Front Door, Molding - Scratch &amp; Dent - Small / Front Bumper, Grille, Lamps - Scratch &amp; Dent - Large / Bonnet, Headlight - Dent - Small / Rear Bumper, Lamps, Panels - Scratch &amp; Dent - Medium / (L) Rear Door, Molding - Scratch - Minimal / (L) Front Door, Molding - Scratch &amp; Dent - Minimal / (R) Front Fender, Molding - Scratch - Small / (R) Rear Fender, Molding - Scratch - Small / Roof - Scratch &amp; Dent - Small</div> |
