General Information

Make	Chevrolet	Model	Colorado
YOM	2014	Odo Meter Reading	168,424
Registration No.	AAQ1697	Chassis No.	MMM148MK0EH608961
CC	2.8	Transmission	M/T
Fuel Type	Diesel	Type of Body	Pickup
Colour	White

Body / Panel Condition

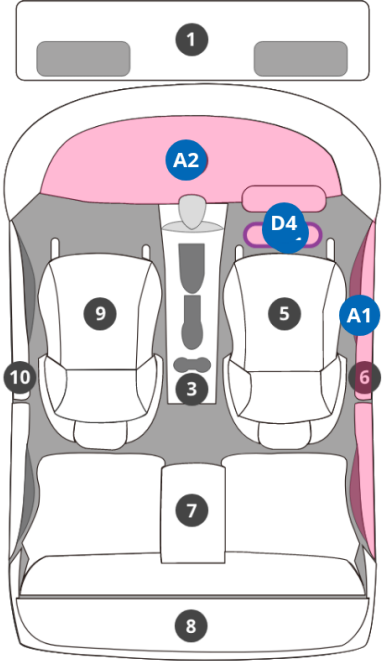
Interior Evaluation : C	Exterior Evaluation : E

<p>a : Cut, Fray d : Loose, Deformed k : Animal Hair s : Smell t : Cigarette Burns x : Defective y : Stain</p>

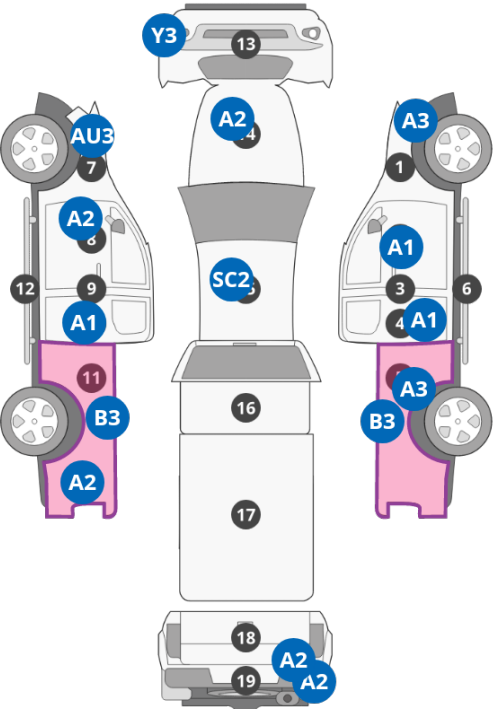
<p>A : Scratch AU : Scratch & Dent B : Modified C : Corrosion G : Stone chip P : Faded S : Rust SC : Rust & Corrosion U : Dent X : Defective Y : Crack, Gap</p>
<p>Remarks Overall Interior - Worn as per age - Yes / Dashboard - Worn, Scratch, Cut, Crack - Small / Mat Other - Missing - Yes / (L) Front Floor Mat - Cut, Crack - Small / (L) Front Floor Mat - Worked - Large / (R) Front Trim - Cut, Crack - Minimal</p>	<p>Remarks (R) Front Door - Repair Traces - Yes / (R) Front Fender - Repair Traces - Yes / Bonnet - Repair Traces - Yes / (L) Front Fender - Repair Traces - Yes / (L) Front Door - Repair Traces - Yes / (L) Rear Door - Repair Traces - Yes / (L) Rear Corner Panel - Repair Traces - Yes / (R) Rear Door - Repair Traces - Yes / Roof - Repair Traces - Yes / (R) Front Door, Molding - Scratch - Minimal / (R) Rear Door, Molding - Scratch - Minimal / (R) Side Gate - Scratch - Medium / Rear Bumper, Lamps, Panels - Scratch - Small / Rear Gate - Scratch - Small / (L) Side Gate - Scratch - Small / (L) Rear Door, Molding - Scratch - Minimal / (L) Front Door, Molding - Scratch - Small / (L) Front Fender, Molding - Scratch & Dent - Medium / (R) Front Fender, Molding - Scratch - Medium / Front Bumper, Grille, Lamps - Crack, Gap - Medium / Bonnet, Headlight - Scratch - Small / Roof - Rust, Corrosion - Small / (L) Side Gate - Modified - Medium / (R) Side Gate - Modified - Medium / (R) Rear Wheel, Cover - Cap Missing - Yes / (L) Rear Wheel, Cover - Cap Missing - Yes</p>
