## General Information

| Make | BMW | Model | X3 |
| YOM | 2021 | Odo Meter Reading | 46,165 |
| Registration No. | CBL4994 | Chassis No. | WBATX310009D13117 |

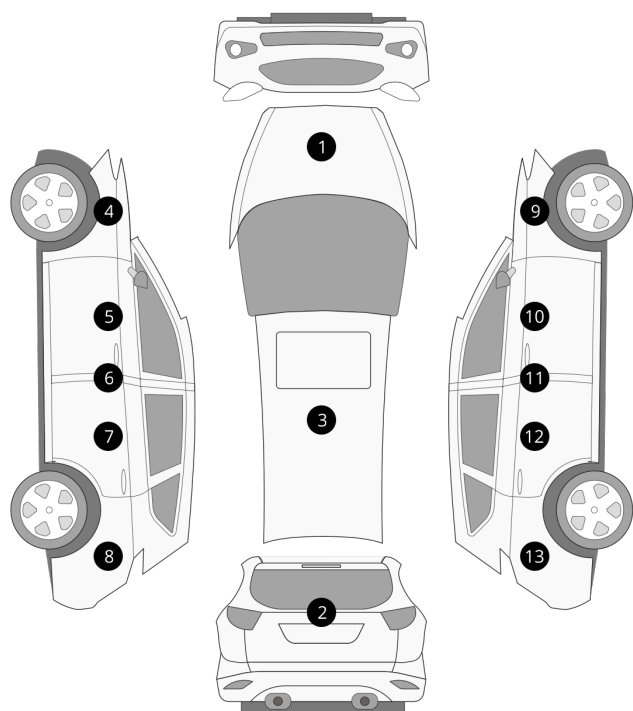
## Body / Panel Condition

| # | Area | Thickness(um) | | | |
|---|---|---|---|---|---|
| 7 | Left Rear Door | 147.6 | 168 | 143 | 132 |
| 8 | Left Back Panel | 204.6 | 205 | 203 | 206 |
| 12 | Right Rear Door | 141.3 | 132 | 140 | 152 |

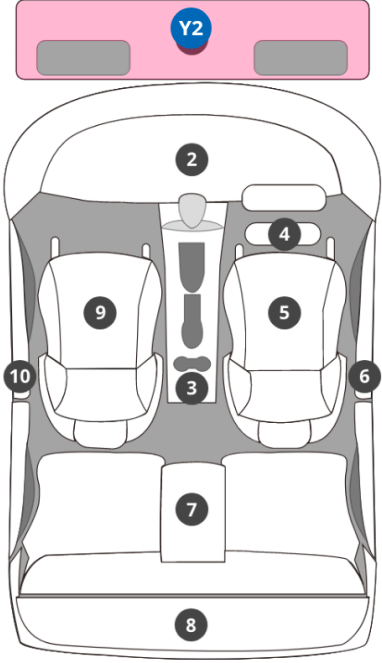
| <b>Interior Evaluation :</b> <span style="color: red; font-weight: bold;">A</span> | <b>Exterior Evaluation :</b> <span style="color: red; font-weight: bold;">C</span> |
| <b>Remarks</b><br>Ceiling - Grime - Small | <b>Remarks</b><br>(L) Rear Fender - Repair Traces - Yes / (R) Rear Fender, Molding - Scratch & Dent - Large / (R) Rear Door, Molding - Scratch & Dent - Small / (L) Rear Fender, Molding - Scratch & Dent - Minimal / (L) Mirror - Scratch - Small / (L) Front Door, Molding - Scratch - Minimal / (L) Front Fender, Molding - Scratch - Small / Bonnet, Headlight - Scratch - Minimal / (R) Mirror - Crack - Damaged / (R) Front Door, Molding - Scratch - Small / Trunk Hood, Rear Gate - Scratch - Minimal / Rear Bumper, Lamps, Panels - Scratch - Small / Roof - Dent - Small |
