## General Information

| Make | Hyundai | Model | Reina |
| YOM | 2019 | Odo Meter Reading | 47,944 |
| Registration No. | LAG3459 | Chassis No. | LBECBAC8LW082925 |

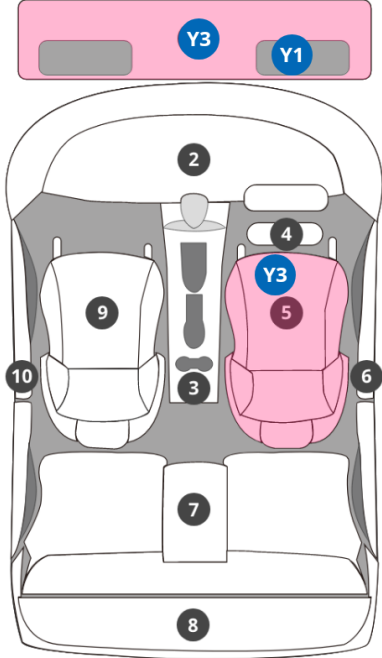
| Interior Evaluation : <span style="color: red; font-weight: bold;">B</span> | | Exterior Evaluation : <span style="color: red; font-weight: bold;">E</span> | |
| <p><b>Remarks</b></p> <p>Ceiling - Grime - Medium / (R) Front Seat - Grime - Medium / Sunvisor, Sunglass Holder - Grime - Minimal</p> | | <p><b>Remarks</b></p> <p>(L) Rear Door, Molding - Scratch - Large / (L) Step, In-panel, Side Spoiler - Scratch - Large / (L) Front Door, Molding - Scratch - Medium / (L) Mirror - Scratch - Minimal / (L) Front Fender, Molding - Scratch - Minimal / Front Bumper, Grille, Lamps - Scratch - Large / Bonnet, Headlight - Scratch - Small / (R) Mirror - Scratch - Small / (R) Front Fender, Molding - Scratch - Medium / (R) Front Door, Molding - Scratch - Large / (R) Rear Door, Molding - Scratch &amp; Dent - Large / (R) Rear Fender, Molding - Scratch - Small / Trunk Hood, Rear Gate - Scratch - Medium / Rear Bumper, Lamps, Panels - Scratch &amp; Dent - Medium / (L) Rear Fender, Molding - Scratch - Small</p> | |
