## General Information

| Make | Toyota | Model | Vios |
| YOM | 2023 | Mileage | 18,608 |
| Registration No. | NHR4477 | Chassis No. | PA1B18F3XP4225796 |

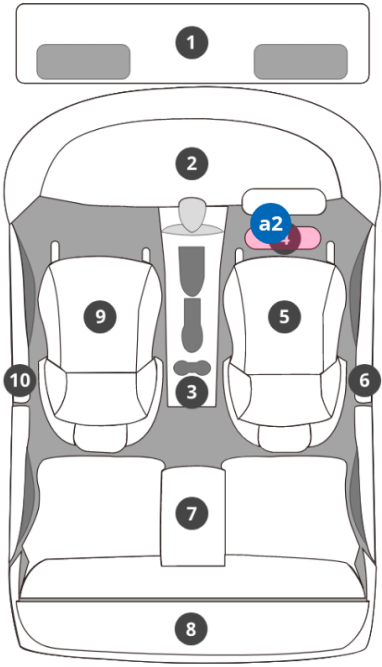
| <b>Remarks</b><br>(L) Front Floor Lag - Cut, Crack - Small | <b>Remarks</b><br>Bonnet, Headlight - Scratch & Dent - Medium / Front Bumper, Grille, Lamps - Scratch & Dent - Medium / (L) Mirror - Crack - Damaged / (L) Rear Door, Molding - Scratch - Small / Trunk Hood, Rear Gate - Dent - Minimal / Rear Bumper, Lamps, Panels - Dent - Minimal / (R) Rear Fender, Molding - Scratch - Minimal / (R) Rear Door, Molding - Scratch & Dent - Small / (R) Step, In-panel, Side Spoiler - Scratch & Dent - Small / (R) Front Fender, Molding - Scratch & Dent - Small / (L) Front Wheel, Cover - Scratch, Corrosion - Small / (L) Rear Wheel, Cover - Scratch, Corrosion - Small / (R) Rear Wheel, Cover - Scratch, Corrosion - Small / (R) Front Wheel, Cover - Scratch, Corrosion - Small |
