General Information

Make	Suzuki	Model	Swift
YOM	2018	Odo Meter Reading	45,942
Registration No.	NAK7954	Chassis No.	MA3ZC6SXXKAD97844
CC	1.2	Transmission	A/T
Fuel Type	Gas	Type of Body	Hatchback
Colour	White

Body / Panel Condition

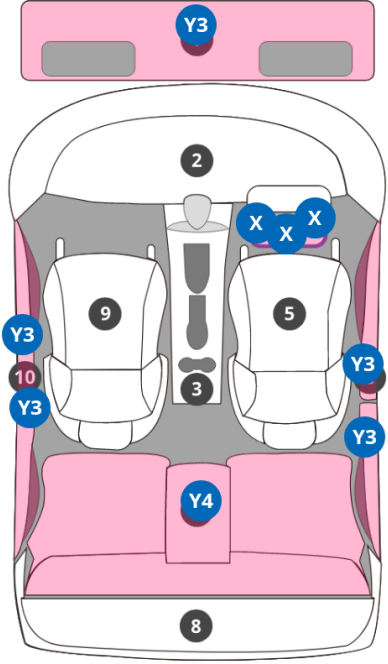
Interior Evaluation : C	Exterior Evaluation : C

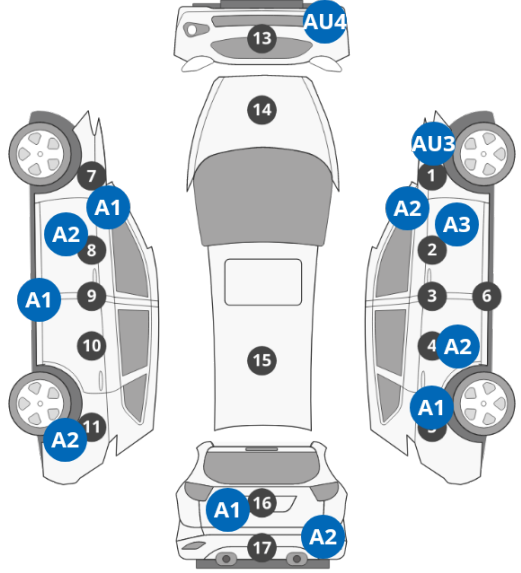
<p>A : Scratch AU : Scratch & Dent B : Modified C : Corrosion G : Stone chip P : Faded S : Rust SC : Rust & Corrosion U : Dent X : Defective Y : Crack, Gap</p>
<p>Remarks Ceiling - Grime - Medium / (R) Front Floor Mat - Missing - Yes / (L) Front Floor Mat - Missing - Yes / Mat Other - Missing - Yes / (R) Front Trim - Grime - Medium / Rear Seat - Grime - Large / (L) Rear Trim - Grime - Medium / (L) Front Trim - Grime - Medium / (R) Rear Trim - Grime - Medium</p>	<p>Remarks (R) Front Door - Repair Traces - Yes / (R) Front Fender - Repair Traces - Yes / Bonnet - Repair Traces - Yes / (L) Front Fender - Repair Traces - Yes / (L) Front Door - Repair Traces - Yes / (L) Rear Door - Repair Traces - Yes / (L) Rear Fender - Repair Traces - Yes / Trunk Hood, Rear Gate - Repair Traces - Yes / (R) Rear Fender - Repair Traces - Yes / (R) Rear Door - Repair Traces - Yes / Roof - Repair Traces - Yes / Front Bumper, Grille, Lamps - Scratch & Dent - Large / (R) Front Fender, Molding - Scratch & Dent - Medium / (R) Mirror - Scratch - Small / (R) Front Door, Molding - Scratch - Medium / (R) Rear Door, Molding - Scratch - Small / (R) Rear Fender, Molding - Scratch - Minimal / Trunk Hood, Rear Gate - Scratch - Minimal / Rear Bumper, Lamps, Panels - Scratch - Small / (L) Rear Fender, Molding - Scratch - Small / (L) Mirror - Scratch - Minimal / (L) Front Door, Molding - Scratch - Small / (L) Step, In-panel, Side Spoiler - Scratch - Minimal</p>
