## General Information

| Make | Mazda | Model | Mazda 2 |
| Registration No. | NDH7537 | Chassis No. | MM7DL2SAAGW151214 |

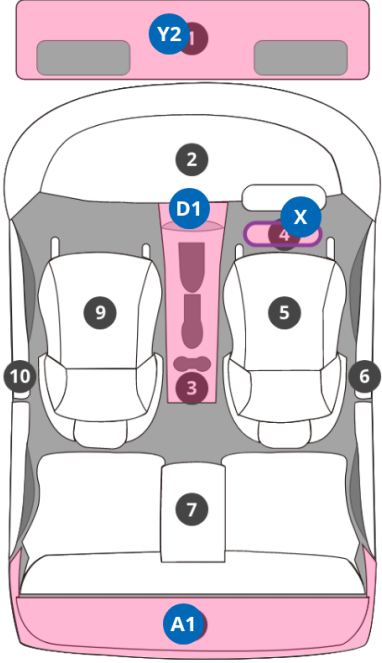
| Interior Evaluation : <span style="color: red;">C</span> | Exterior Evaluation : <span style="color: red;">C</span> |
| <p><b>Remarks</b></p> <p>Trunk Room - Worn, Scratch, Cut, Crack - Minimal / (R)<br/>Front Floor Mat - Missing - Yes / Console, Switches,<br/>Vents - Loose, Deformed - Minimal / Ceiling - Grime -<br/>Small / Overall Interior - Worn as per age - Yes</p> | <p><b>Remarks</b></p> <p>(R) Front Door - Repair Traces - Yes / (R) Front Fender - Repair Traces - Yes / Bonnet - Repair Traces - Yes / (L) Front Fender - Repair Traces - Yes / (L) Front Door - Repair Traces - Yes / (L) Rear Door - Repair Traces - Yes / (L) Rear Fender - Repair Traces - Yes / Trunk Hood, Rear Gate - Repair Traces - Yes / Roof - Repair Traces - Yes / Overall Exterior - Full Re-Paint in same color - Yes / Overall Exterior - Faded(Color, Gloss) - Yes / Overall Exterior - Worn as per age - Yes / (R) Front Fender, Molding - Scratch - Minimal / (R) Front Door, Molding - Scratch &amp; Dent - Small / (R) Mirror - Scratch, Peeled - Yes / (R) Rear Door, Molding - Scratch - Minimal / (R) Rear Fender, Molding - Scratch - Minimal / Rear Bumper, Lamps, Panels - Scratch - Small / Trunk Hood, Rear Gate - Scratch - Small / (L) Rear Fender, Molding - Scratch - Minimal / (L) Rear Door, Molding - Scratch - Small / (L) Front Door, Molding - Scratch - Small / (L) Mirror - Scratch - Small / (L) Front Fender, Molding - Scratch - Minimal / Front Bumper, Grille, Lamps - Scratch - Small / Roof - Scratch - Small / Bonnet, Headlight - Rust, Corrosion - Small</p> |
