## General Information

| Make | Toyota | Model | Vios |
| YOM | 2022 | Odo Meter Reading | 30,702 |
| Registration No. | NFI6813 | Chassis No. | PA1B18F35M4163378 |

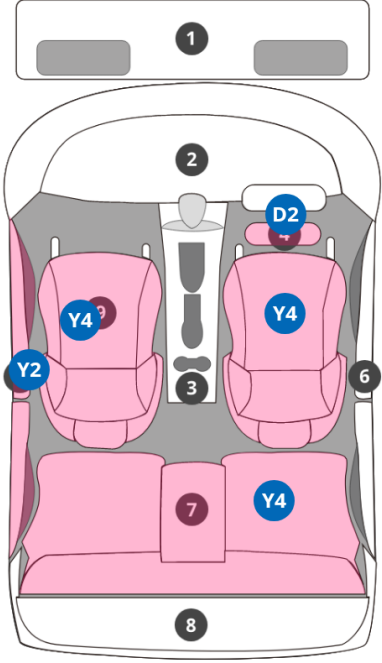
| Interior Evaluation : <b>C</b> | Exterior Evaluation : <b>E</b> |
|---|---|
| <p><b>Remarks</b></p> <p>Rear Seat - Grime - Large / Mat Other - Worked - Small / (R) Front Seat - Grime - Large / (L) Front Seat - Grime - Large / (L) Front Trim - Grime - Small</p> | <p><b>Remarks</b></p> <p>(L) Rear Door - Repair Traces - Yes / (R) Rear Door - Repair Traces - Yes / Overall Exterior - Faded(Color, Gloss) - Yes / (R) Rear Door, Molding - Repair mark - Yes / (R) Rear Fender, Molding - Repair mark - Yes / Rear Bumper, Lamps, Panels - Repair mark - Yes / (L) Rear Fender, Molding - Repair mark - Yes / (L) Front Door, Molding - Repair mark - Yes / (L) Rear Door, Molding - Repair mark - Yes / (R) Front Fender, Molding - Repair mark - Yes / (R) Front Fender, Molding - Scratch - Small / (R) Front Door, Molding - Scratch &amp; Dent - Small / (R) Rear Door, Molding - Scratch - Medium / (R) Rear Fender, Molding - Scratch - Small / Trunk Hood, Rear Gate - Scratch - Small / Trunk Hood, Rear Gate - Repair mark - Yes / (L) Rear Fender, Molding - Scratch - Minimal / (L) Rear Door, Molding - Scratch - Minimal / (L) Front Door, Molding - Scratch - Small / (L) Mirror - Scratch - Minimal / (L) Front Fender, Molding - Scratch - Minimal / Front Bumper, Grille, Lamps - Repair mark - Yes / Front Bumper, Grille, Lamps - Scratch - Medium / Roof - Dent - Small / Bonnet, Headlight - Repair mark - Yes</p> |
