## General Information

| Make | Hino | Model | 315 |
| Registration No. | NHE2284 | Chassis No. | JHHAGP6E30K003052 |

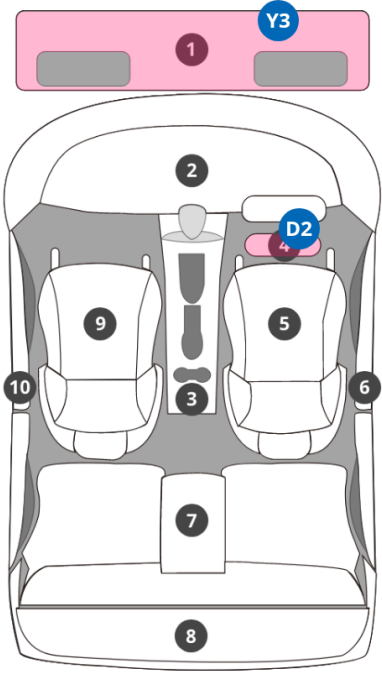
| Interior Evaluation : <b>B</b> | Exterior Evaluation : <b>C</b> |
| <b>Remarks</b><br>(L) Front Floor Mat - Worked - Small / Ceiling - Grime - Medium | <b>Remarks</b><br>Roof - Repair Traces - Yes / (L) Front Door, Molding - Scratch - Small / Front Bumper, Grille, Lamps - Scratch - Small / (R) Front Fender, Molding - Scratch - Small / (R) Front Door, Molding - Scratch - Small / (R) Side Gate - Scratch & Dent - Medium / Rear Gate - Scratch - Medium / (L) Side Gate - Scratch & Dent - Medium / (L) Front Fender, Molding - Scratch - Small / Front Panel - Scratch - Small / Roof - Scratch - Small |
