## General Information

| Make | Toyota | Model | Hiace |
| YOM | 2021 | Odo Meter Reading | 155,637 |
| Registration No. | NEF9149 | Chassis No. | JTFJT02P6L5025635 |

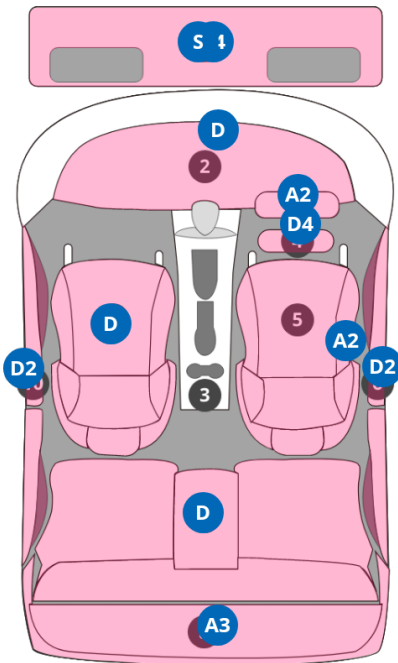
| <b>Interior Evaluation :</b> <span style="color: red; font-weight: bold;">D</span> | <b>Exterior Evaluation :</b> <span style="color: red; font-weight: bold;">E</span> |
| <b>Remarks</b><br>Rear Seat - Worn - Yes / Ceiling - Grime - Large / (R) Front Seat - Cut, Crack - Small / Trunk Room - Worn, Scratch, Cut, Crack - Medium / Overall Interior - Worn as per age - Yes / Overall Interior - Smell - Yes / (L) Front Floor Mat - Worked - Large / Glove Box - Worn, Scratch, Cut, Crack - Small / (L) Front Trim - Worked - Small / (R) Front Trim - Worked - Small / (L) Front Seat - Worn - Yes / Dashboard - Traces of Adhesive Tape - Yes | <b>Remarks</b><br>Front Panel - Replaced - Yes / (L) Rear Door - Repair Traces - Yes / (L) Rear Fender - Repair Traces - Yes / (R) Rear Fender - Repair Traces - Yes / (R) Rear Door - Repair Traces - Yes / (R) Center Panel - Repair Traces - Yes / (R) Center Panel - Replaced - Yes / Roof - Repair Traces - Yes / (R) Rear Door, Molding - Repair mark - Yes / (R) Rear Fender, Molding - Repair mark - Yes / (L) Rear Fender, Molding - Repair mark - Yes / Roof - Repair mark - Yes / (R) Front Door, Molding - Repair mark - Yes / (R) Mirror - Scratch - Small / (R) Front Door, Molding - Scratch - Small / (R) Center Panel - Rust, Corrosion - Large / (R) Rear Door, Molding - Scratch - Small / (R) Rear Fender, Molding - Scratch - Small / (R) Front Wheel, Cover - Scratch, Corrosion - Small / (R) Rear Wheel, Cover - Scratch, Corrosion - Small / Trunk Hood, Rear Gate - Scratch - Small / Rear Bumper, Lamps, Panels - Scratch - Medium / (L) Rear Wheel, Cover - Scratch, Corrosion - Small / (L) Rear Fender, Molding - Scratch & Dent - Large / (L) Rear Door, Molding - Scratch - Medium / (L) Front Door, Molding - Scratch - Small / Roof - Rust, Corrosion - Large / Front Bumper, Grille, Lamps - Crack, Gap - Medium / Front Panel - Scratch - Small |
