## General Information

| Make | Toyota | Model | Vios |
| Registration No. | DAQ5921 | Chassis No. | PA1B18F37N4175758 |

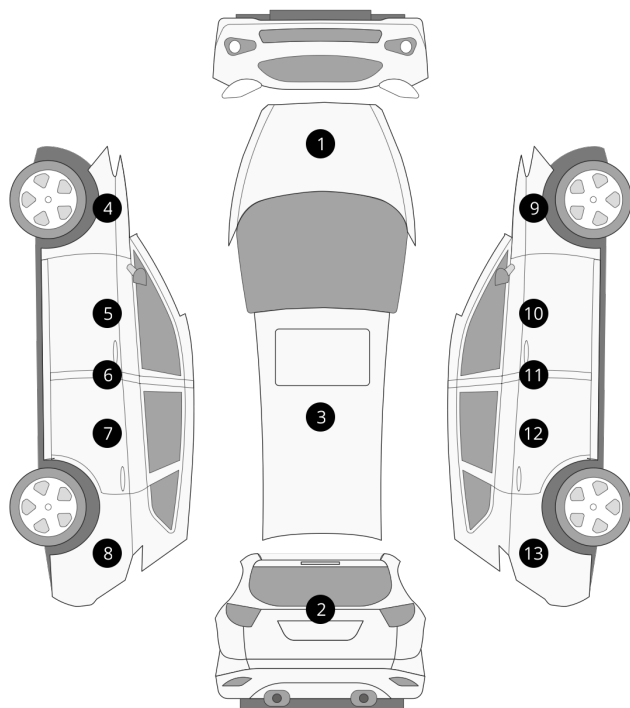
| # | Area | Thickness(um) | | | |
| 1 | Bonnet | 110.3 | 111 | 108 | 112 |
| 2 | Boot Lid | 147.0 | 152 | 135 | 154 |
| 3 | Roof | 94.7 | 99 | 91 | 97/92 |
| 4 | Left Front Fender | 101.6 | 99 | 106 | 100 |
| 5 | Left Front Door | 105.8 | 111 | 108 | 99 |
| 7 | Left Rear Door | 106.0 | 106 | 105 | 107 |
| 8 | Left Back Panel | 109.6 | 132 | 96 | 101 |
| 9 | Right Front Fender | 97.9 | 97 | 100 | 97 |
| 10 | Right Front Door | 101.3 | 100 | 106 | 98 |
| 12 | Right Rear Door | 101.9 | 100 | 99 | 107 |
| 13 | Right Back Panel | 101.6 | 100 | 97 | 108 |

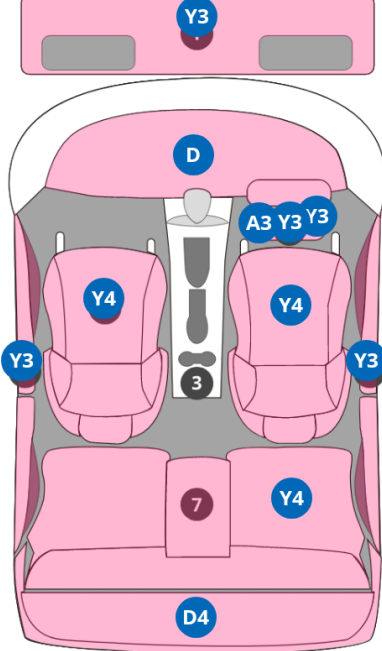
| Interior Evaluation : <b>E</b> | Exterior Evaluation : <b>E</b> |
| <p><b>Remarks</b></p> <p>Ceiling - Grime - Medium / (R) Front Trim - Grime - Medium / (R) Front Seat - Grime - Large / (R) Front Floor Mat - Grime - Medium / Rear Seat - Grime - Large / Trunk Room - Loose, Deformed - Large / Mat Other - Grime - Medium / (L) Front Trim - Grime - Medium / (L) Front Seat - Grime - Large / (L) Front Floor Mat - Cut, Crack - Medium / Dashboard - Traces of Adhesive Tape - Yes</p> | <p><b>Remarks</b></p> <p>(R) Mirror - Scratch - Small / (R) Rear Door, Molding - Scratch - Large / (R) Front Door, Molding - Scratch - Small / (R) Front Fender, Molding - Scratch - Medium / (R) Rear Fender, Molding - Scratch - Large / (L) Rear Fender, Molding - Scratch - Medium / (L) Rear Door, Molding - Scratch - Medium / (L) Mirror - Scratch - Minimal / (L) Front Door, Molding - Scratch - Medium / (L) Step, In-panel, Side Spoiler - Scratch - Minimal / (L) Front Fender, Molding - Scratch - Small / Front Bumper, Grille, Lamps - Scratch &amp; Dent - Large / Bonnet, Headlight - Scratch - Minimal / Trunk Hood, Rear Gate - Scratch - Small / Rear Bumper, Lamps, Panels - Scratch - Medium / Roof - Dent - Small / Front Windshield - Damaged - Large</p> |

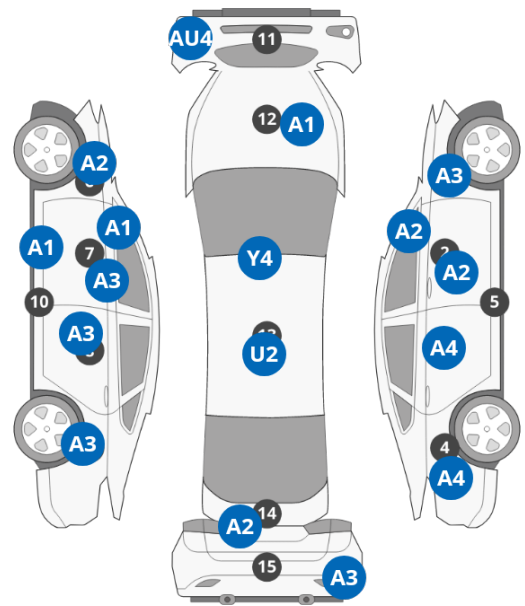
| Inspector Notes |
|---|
| Crack Windshield. Possible flooding. With warranty booklet,jack,tools and seat cover. Spare tire wheel not installed at mags. 1 key. With LTO plate |
