## General Information

Date & Time: 07, Jul, 2025 17:47

<b>Make</b>	Nissan	<b>Model</b>	NV350
<b>YOM</b>	2018	<b>Odo Meter Reading</b>	102,811
<b>Registration No.</b>	NEA5352	<b>Chassis No.</b>	JN1TC2E26Z0052399
<b>CC</b>	2.5	<b>Transmission</b>	M/T
<b>Fuel Type</b>	Diesel	<b>Type of Body</b>	Van
<b>Colour</b>	White

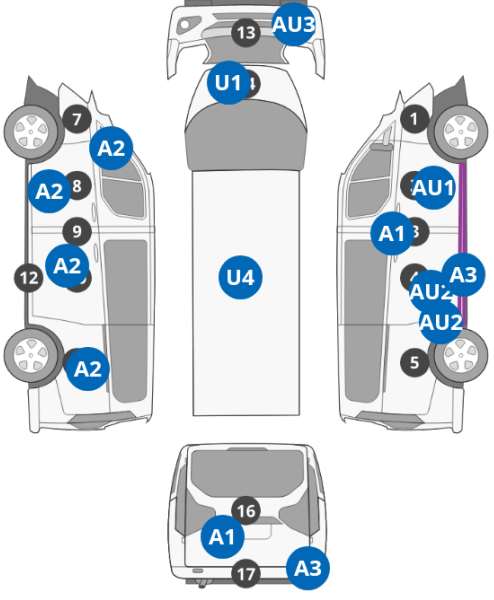
<p><b>A</b> : Scratch <b>AU</b> : Scratch &amp; Dent <b>B</b> : Modified <b>C</b> : Corrosion <b>G</b> : Stone chip <b>P</b> : Faded <b>S</b> : Rust <b>SC</b> : Rust &amp; Corrosion <b>U</b> : Dent <b>X</b> : Defective <b>Y</b> : Crack, Gap</p>
<p><b>Remarks</b> Overall Interior - Worn as per age - Yes / Overall Interior - Smell - Yes / Mat Other - Missing - Yes / (R) Front Floor Mat - Missing - Yes / (L) Front Floor Mat - Missing - Yes / Ceiling - Grime - Large / Sunvisor, Sunglass Holder - Cut, Crack - Small / Dashboard - Traces of Adhesive Tape - Yes</p>	<p><b>Remarks</b> Front Panel - Repair Traces - Yes / Trunk Hood, Rear Gate - Repair Traces - Yes / (R) Rear Door - Repair Traces - Yes / (R) Front Door, Molding - Scratch &amp; Dent - Minimal / (R) Center Panel - Scratch - Minimal / (R) Rear Door, Molding - Scratch &amp; Dent - Small / (R) Step, In-panel, Side Spoiler - Repair mark - Yes / (R) Step, In-panel, Side Spoiler - Scratch - Medium / (R) Rear Fender, Molding - Scratch &amp; Dent - Small / Rear Bumper, Lamps, Panels - Scratch - Medium / Trunk Hood, Rear Gate - Scratch - Minimal / (L) Rear Fender, Molding - Scratch - Small / (L) Rear Door, Molding - Scratch - Small / (L) Front Door, Molding - Scratch - Small / (L) Mirror - Scratch - Small / Front Bumper, Grille, Lamps - Scratch &amp; Dent - Medium / Front Panel - Dent - Minimal / Roof - Dent - Large</p>
