General Information

Date & Time: 07, Jul, 2025 16:53

Make	Suzuki	Model	Ertiga
YOM	2016	Odo Meter Reading	75,200
Registration No.	ECR2030	Chassis No.	MA3ZE81S0G0349089
CC	1.3	Transmission	A/T
Fuel Type	Gas	Type of Body	Wagon
Colour	Red

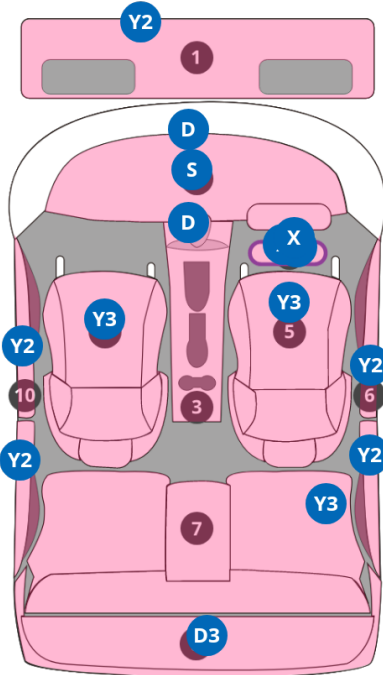
Interior Evaluation : C	Exterior Evaluation : E

<p>a : Cut, Fray d : Loose, Deformed k : Animal Hair s : Smell t : Cigarette Burns x : Defective y : Stain</p>

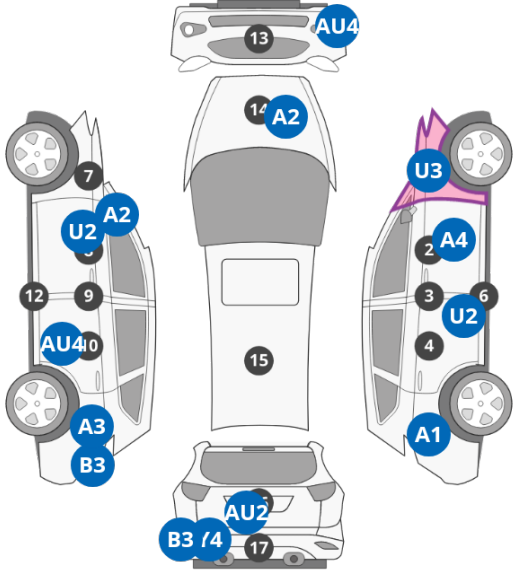
<p>A : Scratch AU : Scratch & Dent B : Modified C : Corrosion G : Stone chip P : Faded S : Rust SC : Rust & Corrosion U : Dent X : Defective Y : Crack, Gap</p>
<p>Remarks Overall Interior - Worn as per age - Yes / Overall Interior - Smell - Yes / Rear Seat - Grime - Medium / (R) Front Seat - Grime - Medium / (L) Front Seat - Grime - Medium / (R) Front Trim - Grime - Small / (L) Front Trim - Grime - Small / (R) Rear Trim - Grime - Small / (L) Rear Trim - Grime - Small / Console, Switchs, Vents - Traces of Adhesive Tape - Yes / Ceiling - Grime - Small / Dashboard - Traces of Adhesive Tape - Yes / Trunk Room - Loose, Deformed - Medium / Mat Other - Missing - Yes / (R) Front Floor Mat - Missing - Yes / (L) Front Floor Mat - Missing - Yes</p>	<p>Remarks (R) Front Door - Repair Traces - Yes / (R) Step - Repair Traces - Yes / (R) Front Fender - Repair Traces - Yes / Bonnet - Repair Traces - Yes / (L) Front Fender - Repair Traces - Yes / (L) Front Door - Repair Traces - Yes / (L) Step - Repair Traces - Yes / (L) Rear Door - Repair Traces - Yes / (L) Rear Fender - Repair Traces - Yes / Trunk Hood, Rear Gate - Repair Traces - Yes / (R) Rear Fender - Repair Traces - Yes / (R) Rear Door - Repair Traces - Yes / Roof - Repair Traces - Yes / (R) Front Fender, Molding - Dent - Medium / (R) Front Door, Molding - Scratch - Large / (R) Rear Door, Molding - Dent - Small / (R) Rear Fender, Molding - Scratch - Minimal / Rear Bumper, Lamps, Panels - Crack, Gap - Large / Trunk Hood, Rear Gate - Scratch & Dent - Small / Rear Bumper, Lamps, Panels - Modified - Medium / (L) Rear Fender, Molding - Modified - Medium / (L) Rear Fender, Molding - Scratch - Medium / (L) Rear Door, Molding - Scratch & Dent - Large / (L) Front Door, Molding - Dent - Small / (L) Mirror - Scratch - Small / Front Bumper, Grille, Lamps - Scratch & Dent - Large / Bonnet, Headlight - Scratch - Small / (R) Front Wheel, Cover - Cap Missing - Yes / Overall Exterior - Color Change - Yes</p>
