General Information

Make	Mitsubishi	Model	Mirage
YOM	2017	Odo Meter Reading	99,685
Registration No.	NAR9547	Chassis No.	MMBSTA13AHH006565
CC	1.2	Transmission	A/T
Fuel Type	Gas	Type of Body	Sedan
Colour	Red

Body / Panel Condition

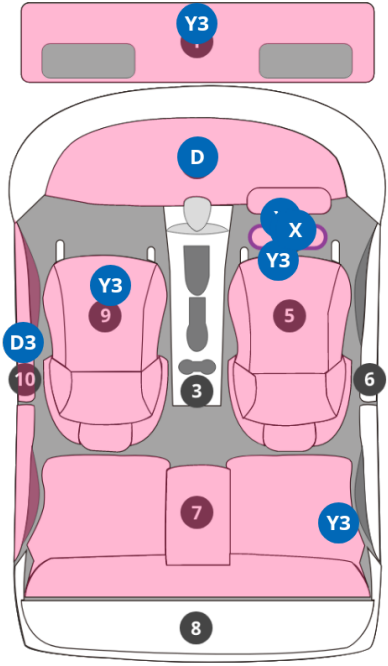
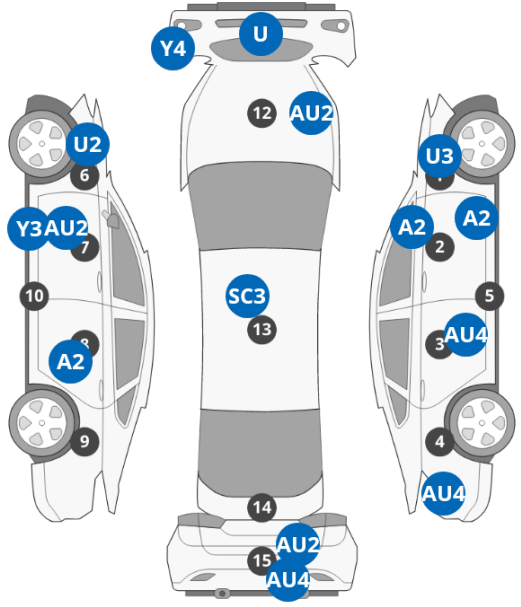
Interior Evaluation : C	Exterior Evaluation : E

<p>a : Cut, Fray d : Loose, Deformed k : Animal Hair s : Smell t : Cigarette Burns x : Defective y : Stain</p>	<p>A : Scratch AU : Scratch & Dent B : Modified C : Corrosion G : Stone chip P : Faded S : Rust SC : Rust & Corrosion U : Dent X : Defective Y : Crack, Gap</p>
<p>Remarks Overall Interior - Worn as per age - Yes / (L) Front Seat - Grime - Medium / (R) Front Seat - Grime - Medium / Rear Seat - Grime - Medium / (L) Front Trim - Loose, Deformed - Medium / Mat Other - Missing - Yes / (L) Front Floor Mat - Missing - Yes / (R) Front Floor Mat - Missing - Yes / Dashboard - Traces of Adhesive Tape - Yes / Ceiling - Grime - Medium</p>	<p>Remarks (R) Front Door - Repair Traces - Yes / (R) Front Fender - Repair Traces - Yes / Bonnet - Repair Traces - Yes / (L) Front Fender - Repair Traces - Yes / (L) Front Door - Repair Traces - Yes / (L) Rear Door - Repair Traces - Yes / (L) Rear Fender - Repair Traces - Yes / Trunk Hood, Rear Gate - Repair Traces - Yes / (R) Rear Fender - Repair Traces - Yes / (R) Rear Door - Repair Traces - Yes / Roof - Repair Traces - Yes / (R) Front Fender, Molding - Dent - Medium / (R) Mirror - Scratch - Small / (R) Front Door, Molding - Scratch - Small / (R) Rear Fender, Molding - Scratch & Dent - Large / Rear Bumper, Lamps, Panels - Scratch & Dent - Large / Trunk Hood, Rear Gate - Scratch & Dent - Small / (L) Step, In-panel, Side Spoiler - Crack, Gap - Medium / (L) Rear Door, Molding - Scratch - Small / (L) Front Door, Molding - Scratch & Dent - Small / (L) Front Fender, Molding - Dent - Small / Front Bumper, Grille, Lamps - Crack, Gap - Large / Member (Bolted) - Dent - Yes / Bonnet, Headlight - Scratch & Dent - Small / (R) Rear Door, Molding - Scratch & Dent - Large / Roof - Rust, Corrosion - Medium</p>
