General Information

Make	Nissan	Model	NV350
YOM	2018	Odo Meter Reading	14,947
Registration No.	CAK4597	Chassis No.	JN1UC4E26Z0020374
CC	2.5	Transmission	A/T
Fuel Type	Diesel	Type of Body	Van
Colour	Silver

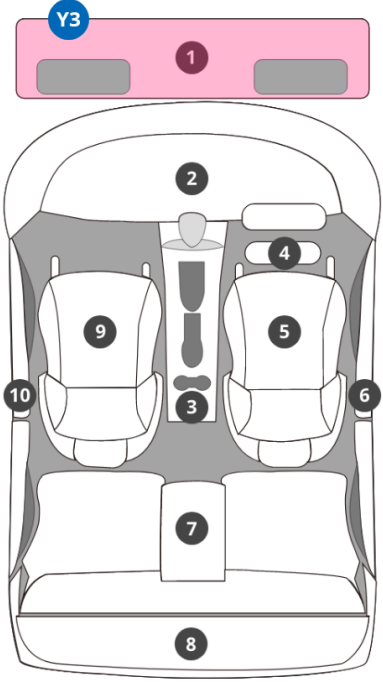
Interior Evaluation : C	Exterior Evaluation : E

<p>A : Scratch AU : Scratch & Dent B : Modified C : Corrosion G : Stone chip P : Faded S : Rust SC : Rust & Corrosion U : Dent X : Defective Y : Crack, Gap</p>
<p>Remarks Overall Interior - Worn as per age - Yes / Ceiling - Grime - Medium</p>	<p>Remarks (R) Front Door - Repair Traces - Yes / (L) Rear Fender - Repair Traces - Yes / Trunk Hood, Rear Gate - Repair Traces - Yes / (R) Rear Fender - Repair Traces - Yes / (R) Rear Fender - Replaced - Yes / (R) Rear Door - Repair Traces - Yes / Roof - Repair Traces - Yes / (R) Mirror - Scratch - Minimal / (R) Center Panel - Scratch - Small / (R) Front Door, Molding - Scratch - Minimal / (R) Rear Fender, Molding - Scratch & Dent - Large / (R) Rear Door, Molding - Scratch - Medium / Trunk Hood, Rear Gate - Scratch & Dent - Small / Rear Bumper, Lamps, Panels - Repair mark - Yes / Rear Bumper, Lamps, Panels - Scratch & Dent - Medium / (L) Rear Fender, Molding - Scratch & Dent - Large / (L) Front Door, Molding - Scratch - Medium / Front Bumper, Grille, Lamps - Scratch & Dent - Large / (R) Front Fender, Molding - Scratch - Minimal / (L) Front Fender, Molding - Rust, Corrosion - Minimal / Front Panel - Scratch & Dent - Minimal / (L) Rear Door, Molding - Scratch & Dent - Large / Roof - Scratch & Dent - Large</p>
