General Information

Make	Subaru	Model	Outback
YOM	2016	Odo Meter Reading	106,647
Registration No.	NCH6270	Chassis No.	JF1BS9LC2GG070066
CC	3.6	Transmission	CVT
Fuel Type	Gas	Type of Body	Wagon
Colour	Silver

Body / Panel Condition

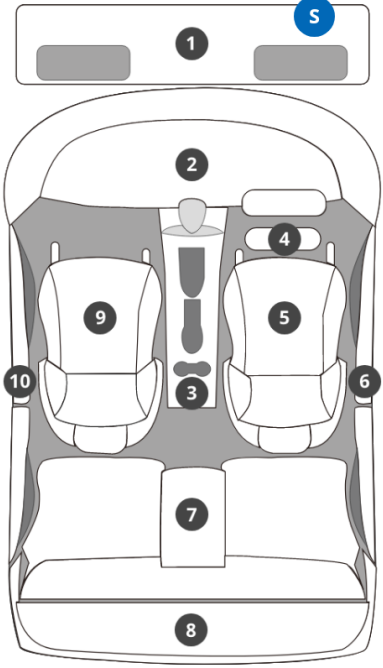
Interior Evaluation : B	Exterior Evaluation : C

<p>A : Scratch AU : Scratch & Dent B : Modified C : Corrosion G : Stone chip P : Faded S : Rust SC : Rust & Corrosion U : Dent X : Defective Y : Crack, Gap</p>
Remarks Overall Interior - Smell - Yes	Remarks (R) Front Door - Repair Traces - Yes / (R) Front Fender - Repair Traces - Yes / Bonnet - Repair Traces - Yes / (L) Front Fender - Repair Traces - Yes / (L) Front Door - Repair Traces - Yes / (L) Rear Door - Repair Traces - Yes / (L) Rear Fender - Repair Traces - Yes / Trunk Hood, Rear Gate - Repair Traces - Yes / (R) Rear Fender - Repair Traces - Yes / Roof - Repair Traces - Yes / (R) Front Door, Molding - Dent - Small / (R) Rear Door, Molding - Scratch - Small / (R) Rear Fender, Molding - Scratch - Small / Rear Bumper, Lamps, Panels - Scratch & Dent - Small / Trunk Hood, Rear Gate - Scratch - Small / (L) Rear Fender, Molding - Scratch - Minimal / (L) Rear Door, Molding - Scratch & Dent - Small / (L) Front Door, Molding - Scratch - Small / (L) Front Fender, Molding - Scratch - Small / (R) Front Fender, Molding - Scratch - Small / Roof Spoiler, Molding - Scratch - Small / Front Bumper, Grille, Lamps - Scratch - Small / Bonnet, Headlight - Scratch - Minimal
