General Information

Date & Time: 14, Jul, 2025 10:50

Make	Toyota	Model	Vios
YOM	2023	Odo Meter Reading	56,021
Registration No.	NII7597-1	Chassis No.	PA1B18F39P4203434
CC	1.3	Transmission	CVT
Fuel Type	Gas	Type of Body	Sedan
Colour	Red

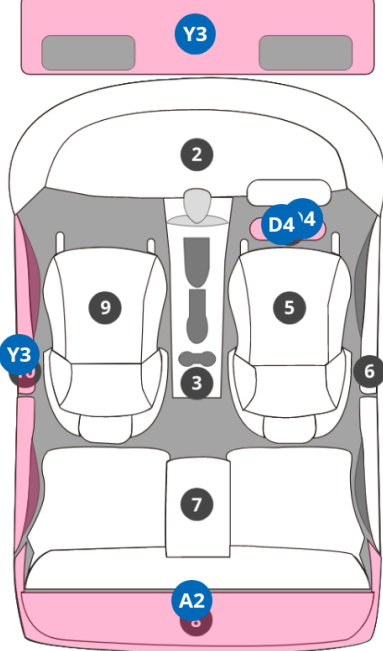
Interior Evaluation : C	Exterior Evaluation : E

<p>a : Cut, Fray d : Loose, Deformed k : Animal Hair s : Smell t : Cigarette Burns x : Defective y : Stain</p>

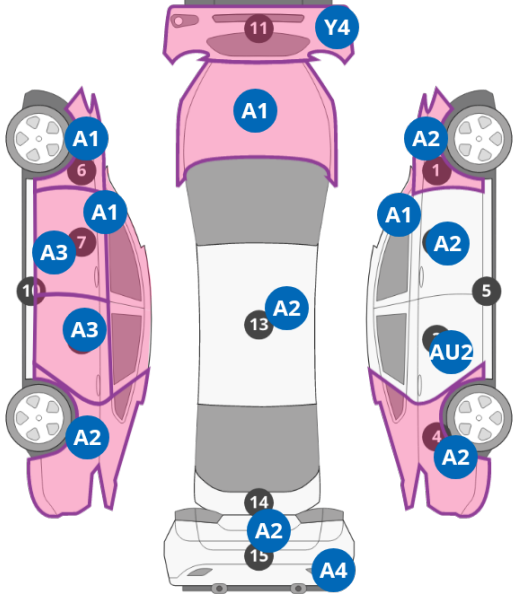
<p>A : Scratch AU : Scratch & Dent B : Modified C : Corrosion G : Stone chip P : Faded S : Rust SC : Rust & Corrosion U : Dent X : Defective Y : Crack, Gap</p>
<p>Remarks Mat Other - Worked - Large / Trunk Room - Worn, Scratch, Cut, Crack - Small / Ceiling - Grime - Medium / (L) Front Trim - Grime - Medium / (L) Front Floor Mat - Worked - Large</p>	<p>Remarks (R) Front Fender - Repair Traces - Yes / Bonnet - Repair Traces - Yes / (L) Front Fender - Repair Traces - Yes / (L) Rear Fender - Repair Traces - Yes / (R) Rear Fender - Repair Traces - Yes / (R) Front Fender, Molding - Repair mark - Yes / (L) Front Fender, Molding - Repair mark - Yes / Bonnet, Headlight - Repair mark - Yes / (L) Rear Fender, Molding - Repair mark - Yes / (R) Rear Fender, Molding - Repair mark - Yes / (R) Front Fender, Molding - Scratch - Small / (R) Mirror - Scratch - Minimal / (R) Front Door, Molding - Scratch - Small / (R) Rear Door, Molding - Scratch & Dent - Small / (R) Rear Fender, Molding - Scratch - Small / Rear Bumper, Lamps, Panels - Scratch - Large / Trunk Hood, Rear Gate - Scratch - Small / (L) Rear Fender, Molding - Scratch - Small / (L) Rear Door, Molding - Repair mark - Yes / (L) Rear Door, Molding - Scratch - Medium / (L) Front Door, Molding - Repair mark - Yes / (L) Front Door, Molding - Scratch - Medium / Roof - Scratch - Small / (L) Mirror - Scratch - Minimal / (L) Front Fender, Molding - Scratch - Minimal / Front Bumper, Grille, Lamps - Crack, Gap - Large / Front Bumper, Grille, Lamps - Repair mark - Yes / Bonnet, Headlight - Scratch - Minimal</p>
