## General Information

<b>Make</b>	Toyota	<b>Model</b>	Vios
<b>YOM</b>	2024	<b>Odo Meter Reading</b>	64,793
<b>Registration No.</b>	DBO4649	<b>Chassis No.</b>	PA1B18F3XP4234224
<b>CC</b>	1.3	<b>Transmission</b>	M/T
<b>Fuel Type</b>	Gas	<b>Type of Body</b>	Sedan
<b>Colour</b>	Black

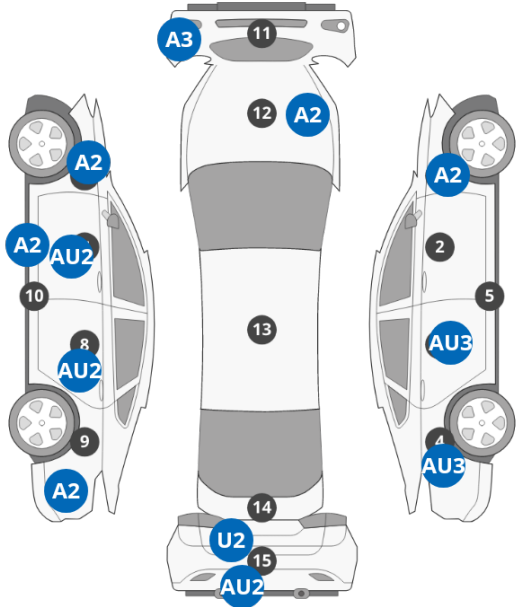
<p><b>A</b> : Scratch <b>AU</b> : Scratch &amp; Dent <b>B</b> : Modified <b>C</b> : Corrosion <b>G</b> : Stone chip <b>P</b> : Faded <b>S</b> : Rust <b>SC</b> : Rust &amp; Corrosion <b>U</b> : Dent <b>X</b> : Defective <b>Y</b> : Crack, Gap</p>
<p><b>Remarks</b> (R) Front Seat - Grime - Large / (R) Front Trim - Grime - Small / Rear Seat - Grime - Medium / Trunk Room - Worn, Scratch, Cut, Crack - Small / (L) Front Seat - Grime - Medium / Ceiling - Grime - Medium / (L) Front Trim - Grime - Medium / Overall Interior - Smell - Yes</p>	<p><b>Remarks</b> Trunk Hood, Rear Gate - Dent - Small / Rear Bumper, Lamps, Panels - Scratch &amp; Dent - Small / (R) Rear Fender, Molding - Scratch &amp; Dent - Medium / (R) Rear Door, Molding - Scratch &amp; Dent - Medium / (R) Front Fender, Molding - Scratch - Small / Bonnet, Headlight - Scratch - Small / Front Bumper, Grille, Lamps - Scratch - Medium / (L) Front Fender, Molding - Scratch - Small / (L) Front Door, Molding - Scratch &amp; Dent - Small / (L) Step, In-panel, Side Spoiler - Scratch - Small / (L) Rear Fender, Molding - Scratch - Small / (L) Rear Door, Molding - Scratch &amp; Dent - Small</p>
