## General Information

| Make | Toyota | Model | Hiace |
| Registration No. | NIH1348 | Chassis No. | JTFNAFAP3N8029090 |

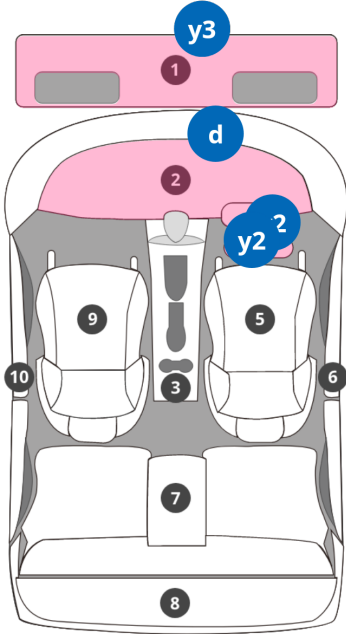
| Interior Evaluation : <b>B</b> | Exterior Evaluation : <b>D</b> |
| <b>Remarks</b><br>(L) Front Floor Mat - Grime - Small / Dashboard - Traces of Adhesive Tape - Yes / Mat Other - Grime - Small / Ceiling - Grime - Medium / Overall Interior - Worn as per age - Yes | <b>Remarks</b><br>(L) Rear Fender, Molding - Scratch & Dent - Large / (L) Rear Wheel, Cover - Cap Missing - Yes / Rear Bumper, Lamps, Panels - Crack, Gap - Small / Trunk Hood, Rear Gate - Dent - Medium / (R) Rear Fender, Molding - Scratch - Medium / (R) Rear Door, Molding - Scratch - Medium / (R) Step, In-panel, Side Spoiler - Scratch & Dent - Small / Roof - Dent - Large / (R) Front Wheel, Cover - Scratch, Corrosion - Small / (R) Rear Wheel, Cover - Scratch, Corrosion - Small / (L) Front Wheel, Cover - Scratch, Corrosion - Small / Front Bumper, Grille, Lamps - Scratch - Medium |
