General Information

Make	Chevrolet	Model	Colorado
YOM	2015	Odo Meter Reading	114,400
Registration No.	MCV5513	Chassis No.	MMM148MH0DH803942
CC	2.8	Transmission	A/T
Fuel Type	Diesel	Type of Body	Pickup
Colour	Silver

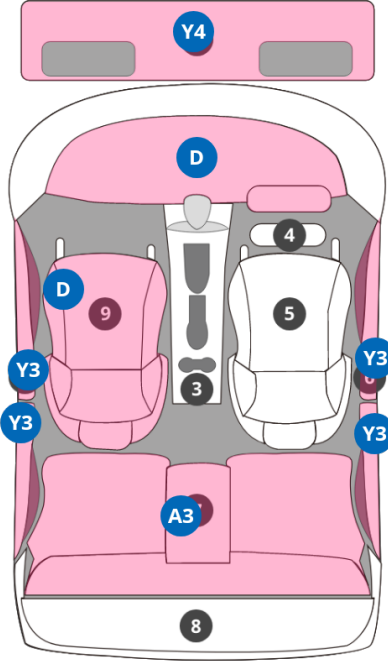
Interior Evaluation : D	Exterior Evaluation : E

<p>a : Cut, Fray d : Loose, Deformed k : Animal Hair s : Smell t : Cigarette Burns x : Defective y : Stain</p>

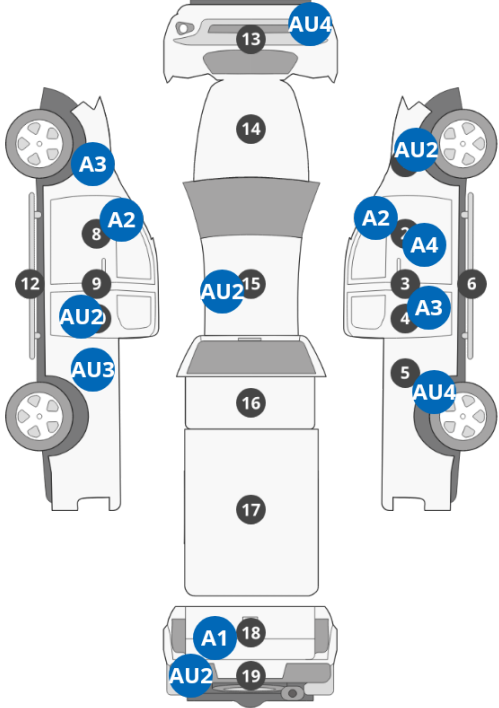
<p>A : Scratch AU : Scratch & Dent B : Modified C : Corrosion G : Stone chip P : Faded S : Rust SC : Rust & Corrosion U : Dent X : Defective Y : Crack, Gap</p>
<p>Remarks Ceiling - Grime - Large / (R) Front Trim - Grime - Medium / (R) Rear Trim - Grime - Medium / (L) Rear Trim - Grime - Medium / Rear Seat - Cut, Crack - Medium / (L) Front Trim - Grime - Medium / (L) Front Seat - Worn - Yes / Dashboard - Traces of Adhesive Tape - Yes</p>	<p>Remarks (L) Front Fender, Molding - Scratch - Medium / (L) Mirror - Scratch - Small / (L) Rear Door, Molding - Scratch & Dent - Small / (L) Side Gate - Scratch & Dent - Medium / Rear Gate - Scratch - Minimal / (R) Rear Door, Molding - Scratch - Medium / (R) Side Gate - Scratch & Dent - Large / (R) Front Door, Molding - Scratch - Large / (R) Mirror - Scratch - Small / (R) Front Fender, Molding - Scratch & Dent - Small / Front Bumper, Grille, Lamps - Scratch & Dent - Large / Rear Bumper, Lamps, Panels - Scratch & Dent - Small / Roof - Scratch & Dent - Small</p>
