General Information

Make	Nissan	Model	NV350
YOM	2018	Odo Meter Reading	163,356
Registration No.	NCM2834	Chassis No.	JN1TC2E6Z0016185
CC	2.5	Transmission	M/T
Fuel Type	Diesel	Type of Body	Van
Colour	Brown

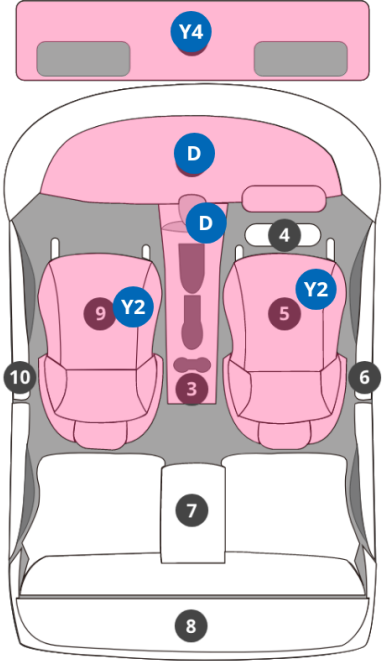
Interior Evaluation : C	Exterior Evaluation : E

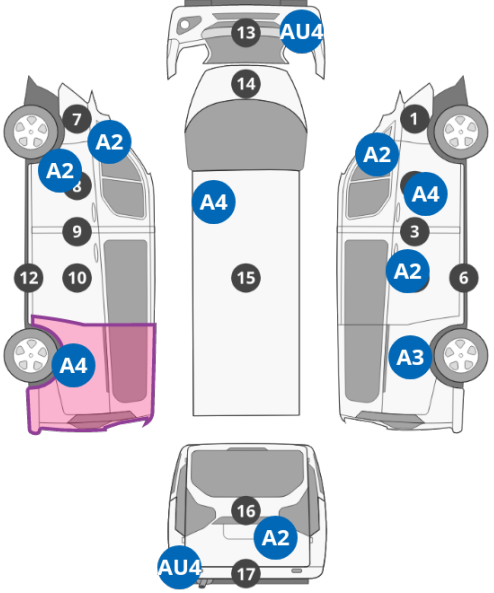
<p>A : Scratch AU : Scratch & Dent B : Modified C : Corrosion G : Stone chip P : Faded S : Rust SC : Rust & Corrosion U : Dent X : Defective Y : Crack, Gap</p>
<p>Remarks (R) Front Seat - Grime - Small / Ceiling - Grime - Large / (L) Front Seat - Grime - Small / Dashboard - Traces of Adhesive Tape - Yes / Console, Switchs, Vents - Traces of Adhesive Tape - Yes</p>	<p>Remarks (R) Front Fender - Repair Traces - Yes / Bonnet - Repair Traces - Yes / (L) Front Door - Repair Traces - Yes / (L) Rear Fender - Repair Traces - Yes / Trunk Hood, Rear Gate - Repair Traces - Yes / Roof - Repair Traces - Yes / (R) Rear Fender, Molding - Scratch - Medium / (R) Rear Door, Molding - Scratch - Small / (R) Front Door, Molding - Scratch - Large / Front Bumper, Grille, Lamps - Scratch & Dent - Large / (R) Mirror - Scratch - Small / (L) Mirror - Scratch - Small / (L) Rear Fender, Molding - Repair mark - Difference in Color / (L) Front Door, Molding - Scratch - Small / (L) Rear Fender, Molding - Scratch - Large / Rear Bumper, Lamps, Panels - Scratch & Dent - Large / Trunk Hood, Rear Gate - Scratch - Small / Roof - Scratch - Large</p>
