## General Information

| Make | Toyota | Model | Hilux |
| Registration No. | NEL1333 | Chassis No. | MR0AB8DD8M5032585 |

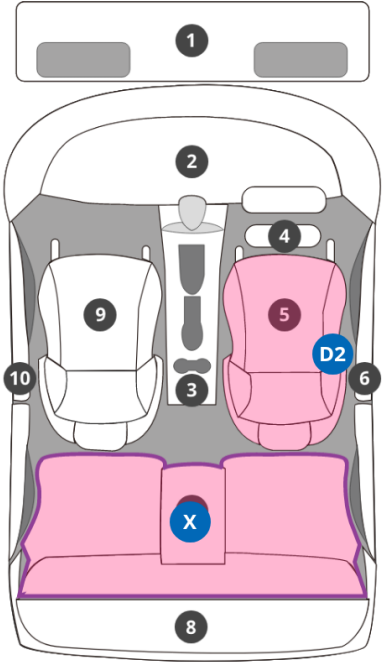
| Interior Evaluation : <b>B</b> | Exterior Evaluation : <b>C</b> |
|---|---|
| <b>Remarks</b><br>Rear Seat Head Rest - Missing - Yes / (R) Front Seat belt - Loose, Deformed - Small | <b>Remarks</b><br>(R) Front Door - Repair Traces - Yes / (L) Front Door - Repair Traces - Yes / (L) Center Panel - Repair Traces - Yes / (R) Rear Door - Repair Traces - Yes / (R) Center Panel - Repair Traces - Yes / (R) Side Gate - Repair mark - Yes / Rear Gate - Scratch & Dent - Medium / Rear Bumper, Lamps, Panels - Scratch - Medium / (L) Side Gate - Crack, Gap - Medium / (L) Rear Wheel, Cover - Scratch, Corrosion - Small / (L) Rear Door, Molding - Scratch - Minimal / (R) Front Door, Molding - Dent - Small / (R) Rear Door, Molding - Repair mark - Yes / (R) Front Door, Molding - Repair mark - Yes / (R) Rear Wheel, Cover - Scratch, Corrosion - Small / Roof - Scratch - Minimal / (L) Front Fender, Molding - Scratch - Minimal / Cargo Bed Floor - Modified - Medium |
