## General Information

| Make | Toyota | Model | Lite Ace |
| Registration No. | DBR6005 | Chassis No. | MHKU3FE10RK009688 |

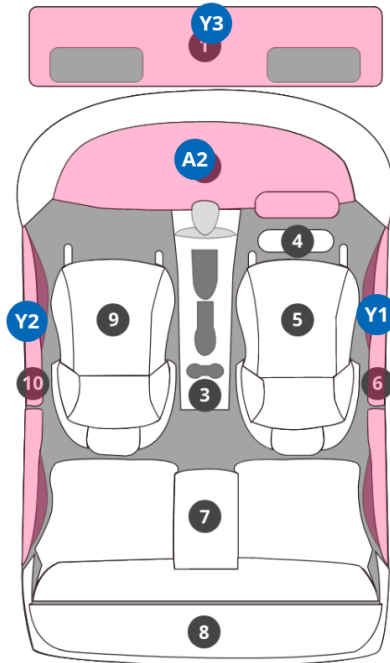
| <b>Remarks</b><br>Dashboard - Worn, Scratch, Cut, Crack - Small / Ceiling - Grime - Medium / (R) Front Trim - Grime - Minimal / (L) Front Trim - Grime - Small | <b>Remarks</b><br>(L) Rear Corner Panel - Repair Traces - Yes / Roof - Repair Traces - Yes / (R) Front Fender, Molding - Crack, Gap - Large / Front Bumper, Grille, Lamps - Scratch & Dent - Medium / (R) Front Door, Molding - Scratch - Minimal / Rear Bumper, Lamps, Panels - Scratch - Medium / (R) Side Gate - Dent - Small / Rear Gate - Scratch & Dent - Small / (L) Front Door, Molding - Scratch - Minimal / (L) Rear Wheel, Cover - Cap Crack - Yes / (L) Side Gate - Scratch - Minimal / Cargo Bed Floor - Scratch & Dent - Large / Roof - Dent - Large |
