## General Information

Date & Time: 17, Jul, 2025 14:52

<b>Make</b>	Toyota	<b>Model</b>	Lite Ace
<b>YOM</b>	2024	<b>Odo Meter Reading</b>	28,851
<b>Registration No.</b>	CCD1673	<b>Chassis No.</b>	MHKU3FE10PK005823
<b>CC</b>	1.5	<b>Transmission</b>	M/T
<b>Fuel Type</b>	Gas	<b>Type of Body</b>	Dropside
<b>Colour</b>	White

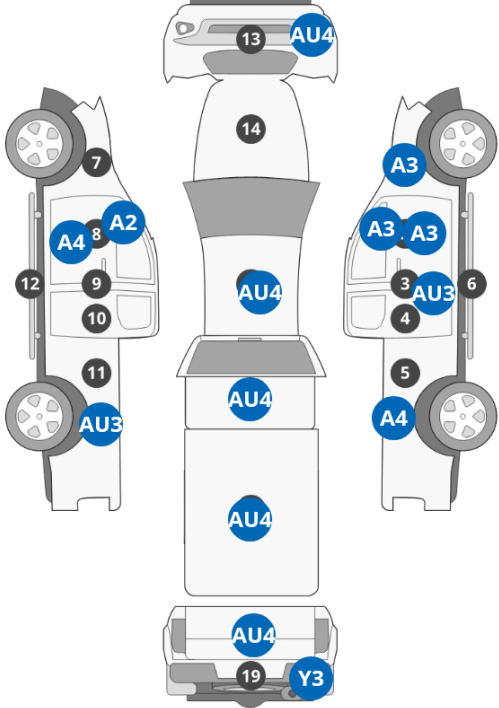
<p><b>A</b> : Scratch <b>AU</b> : Scratch &amp; Dent <b>B</b> : Modified <b>C</b> : Corrosion <b>G</b> : Stone chip <b>P</b> : Faded <b>S</b> : Rust <b>SC</b> : Rust &amp; Corrosion <b>U</b> : Dent <b>X</b> : Defective <b>Y</b> : Crack, Gap</p>
<p><b>Remarks</b> (R) Front Seat - Grime - Small / Mat Other - Grime - Large / Ceiling - Grime - Medium / Sunvisor, Sunglass Holder - Grime - Medium / (L) Front Seat - Grime - Small</p>	<p><b>Remarks</b> Cargo Bed Floor - Scratch &amp; Dent - Large / Cab Back Panel - Scratch &amp; Dent - Large / Rear Gate - Scratch &amp; Dent - Large / (L) Front Door, Molding - Scratch - Large / (L) Mirror - Scratch - Small / (R) Front Fender, Molding - Scratch - Medium / (R) Mirror - Scratch - Medium / (R) Center Panel - Scratch &amp; Dent - Medium / (R) Front Door, Molding - Scratch - Medium / (R) Side Gate - Scratch - Large / (L) Side Gate - Scratch &amp; Dent - Medium / Roof - Scratch &amp; Dent - Large / Front Bumper, Grille, Lamps - Scratch &amp; Dent - Large / Rear Bumper, Lamps, Panels - Crack, Gap - Medium</p>

<p><b>Inspector Notes</b></p>
<p>Crack signal light. With warranty booklet and spare tire. Without jack and tools. 1 key. With LTO plate.</p>
