## General Information

| Make | Toyota | Model | Vios |
| Registration No. | NIQ6907 | Chassis No. | PA1B18F33P4230855 |

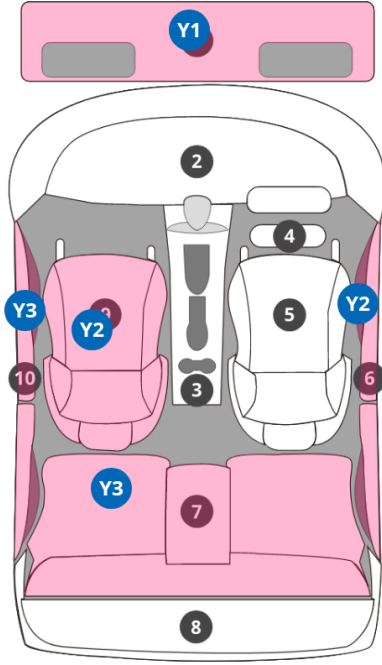
| Interior Evaluation : <b>B</b> | Exterior Evaluation : <b>C</b> |
|---|---|
| <p><b>Remarks</b><br/>Rear Seat - Grime - Medium / (L) Front Trim - Grime - Medium / (L) Front Seat - Grime - Small / (R) Front Trim - Grime - Small / Ceiling - Grime - Minimal</p> | <p><b>Remarks</b><br/>(L) Front Fender, Molding - Dent - Medium / (L) Front Door, Molding - Scratch &amp; Dent - Large / (L) Rear Fender, Molding - Dent - Medium / Trunk Hood, Rear Gate - Dent - Small / Rear Bumper, Lamps, Panels - Scratch &amp; Dent - Small / (R) Rear Fender, Molding - Scratch - Small / (R) Rear Door, Molding - Scratch - Small / (R) Front Door, Molding - Scratch - Minimal</p> |
