## General Information

<b>Make</b>	Toyota	<b>Model</b>	Vios
<b>YOM</b>	2024	<b>Odo Meter Reading</b>	55,491
<b>Registration No.</b>	DBJ7862	<b>Chassis No.</b>	PA1B18F34P4227172
<b>CC</b>	1.3	<b>Transmission</b>	M/T
<b>Fuel Type</b>	Gas	<b>Type of Body</b>	Sedan
<b>Colour</b>	Green

## Body / Panel Condition

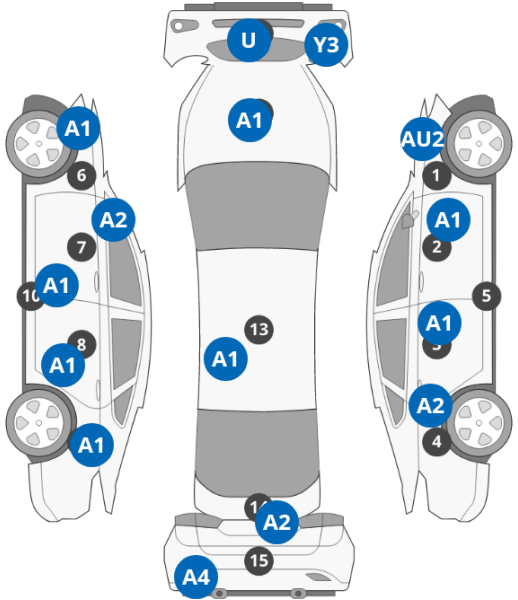
<p><b>A</b> : Scratch <b>AU</b> : Scratch &amp; Dent <b>B</b> : Modified <b>C</b> : Corrosion <b>G</b> : Stone chip <b>P</b> : Faded <b>S</b> : Rust <b>SC</b> : Rust &amp; Corrosion <b>U</b> : Dent <b>X</b> : Defective <b>Y</b> : Crack, Gap</p>
<p><b>Remarks</b> Trunk Room - Worn, Scratch, Cut, Crack - Medium / Rear Seat - Grime - Large / (R) Front Seat - Grime - Large / (L) Front Seat - Grime - Medium / (L) Front Floor Mat - Worked - Large / (L) Front Trim - Grime - Small</p>	<p><b>Remarks</b> (R) Front Fender, Molding - Scratch &amp; Dent - Small / (R) Front Door, Molding - Scratch - Minimal / (R) Rear Door, Molding - Scratch - Minimal / (R) Rear Fender, Molding - Scratch - Small / Rear Bumper, Lamps, Panels - Scratch - Large / Trunk Hood, Rear Gate - Scratch - Small / (L) Rear Fender, Molding - Scratch - Minimal / (L) Rear Door, Molding - Scratch - Minimal / (L) Front Door, Molding - Scratch - Minimal / (L) Mirror - Scratch - Small / (L) Front Fender, Molding - Scratch - Minimal / Roof - Scratch - Minimal / Member (Bolted) - Dent - Yes / Front Bumper, Grille, Lamps - Crack, Gap - Medium / Bonnet, Headlight - Scratch - Minimal</p>
