## General Information

| Make | Toyota | Model | Vios |
| YOM | 2023 | Odo Meter Reading | 121,237 |
| Registration No. | NIH1252 | Chassis No. | PA1B18F33N4196882 |

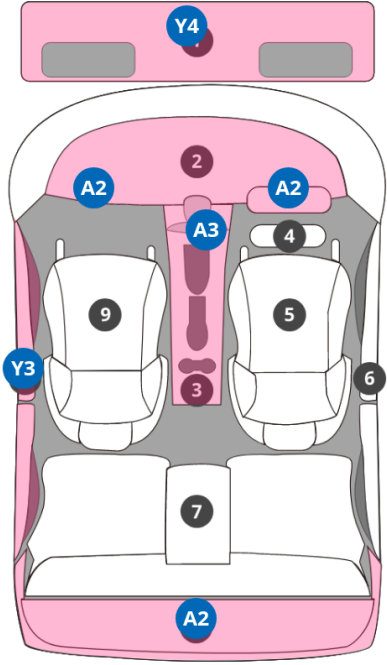
| Interior Evaluation : <b>C</b> | Exterior Evaluation : <b>E</b> |
| <p><b>Remarks</b></p> <p>Knobs - Worn, Peel, Crack - Medium / Ceiling - Grime - Large / Overall Interior - Worn as per age - Yes / (L) Front Trim - Grime - Medium / Steering Wheel - Worn, Peel, Crack - Small / Dashboard - Worn, Scratch, Cut, Crack - Small / Trunk Room - Worn, Scratch, Cut, Crack - Small</p> | <p><b>Remarks</b></p> <p>(R) Front Door - Repair Traces - Yes / (R) Step - Repair Traces - Yes / (R) Front Fender - Repair Traces - Yes / Bonnet - Repair Traces - Yes / (L) Front Fender - Repair Traces - Yes / (L) Front Door - Repair Traces - Yes / (L) Step - Repair Traces - Yes / (L) Rear Door - Repair Traces - Yes / (L) Rear Fender - Repair Traces - Yes / Trunk Hood, Rear Gate - Repair Traces - Yes / (R) Rear Fender - Repair Traces - Yes / (R) Rear Door - Repair Traces - Yes / Roof - Repair Traces - Yes / Member (Bolted) - Dent - Yes / (R) Front Fender, Molding - Scratch &amp; Dent - Medium / (R) Mirror - Scratch - Small / (R) Front Door, Molding - Scratch &amp; Dent - Medium / (R) Rear Door, Molding - Scratch &amp; Dent - Large / (R) Step, In-panel, Side Spoiler - Dent - Medium / (R) Rear Fender, Molding - Scratch &amp; Dent - Medium / Overall Exterior - Re-Paint Uneven - Yes / Rear Bumper, Lamps, Panels - Scratch - Large / Trunk Hood, Rear Gate - Scratch &amp; Dent - Medium / (L) Rear Fender, Molding - Dent - Medium / (L) Rear Door, Molding - Scratch - Small / (L) Front Door, Molding - Scratch &amp; Dent - Small / (L) Mirror - Crack - Damaged / Front Bumper, Grille, Lamps - Modified - Medium / Front Bumper, Grille, Lamps - Scratch &amp; Dent - Large / Bonnet, Headlight - Scratch - Small / Roof - Scratch &amp; Dent - Small / Rear Bumper, Lamps, Panels - Modified - Minimal</p> |
