## General Information

| Make | Toyota | Model | Innova |
| Registration No. | DAQ7327 | Chassis No. | PA2JA8EM1N0106105 |

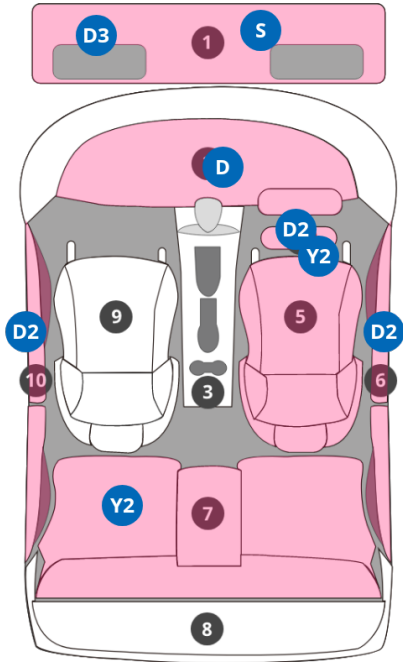
| <b>Interior Evaluation :</b> <b>B</b> | <b>Exterior Evaluation :</b> <b>C</b> |
| <b>Remarks</b><br>Ceiling - Crinkle - Medium / Overall Interior - Smell - Yes / (R) Front Seat - Grime - Small / Rear Seat - Grime - Small / (L) Front Floor Mat - Worked - Small / (L) Front Trim - Worked - Small / (R) Front Trim - Worked - Small / Dashboard - Traces of Adhesive Tape - Yes | <b>Remarks</b><br>(L) Front Door, Molding - Scratch - Small / (L) Rear Door, Molding - Scratch - Small / (L) Front Fender, Molding - Scratch - Minimal / Member (Bolted) - Dent - Yes / Front Bumper, Grille, Lamps - Scratch - Small / (R) Front Fender, Molding - Scratch - Small / (R) Front Door, Molding - Scratch - Small / (R) Rear Door, Molding - Scratch - Small / (R) Step, In-panel, Side Spoiler - Scratch - Small / Rear Bumper, Lamps, Panels - Scratch - Medium / Trunk Hood, Rear Gate - Scratch & Dent - Small / (L) Rear Fender, Molding - Scratch & Dent - Small / (R) Rear Fender, Molding - Scratch - Small / Roof - Scratch - Minimal / Bonnet, Headlight - Scratch - Minimal |
