## General Information

| Make | Toyota | Model | Vios |
| Registration No. | NFH8620 | Chassis No. | PA1B18F38N4177793 |

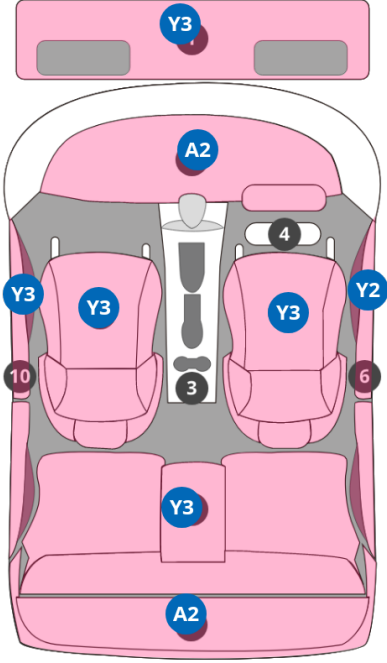
| Interior Evaluation : <span style="color: red;">C</span> | Exterior Evaluation : <span style="color: red;">E</span> |
| <b>Remarks</b><br>(L) Front Trim - Grime - Medium / Ceiling - Grime - Medium / Rear Seat - Grime - Medium / (L) Front Seat - Grime - Medium / Trunk Room - Worn, Scratch, Cut, Crack - Small / (R) Front Seat - Grime - Medium / (R) Front Trim - Grime - Small / Dashboard - Worn, Scratch, Cut, Crack - Small | <b>Remarks</b><br>(R) Front Fender - Repair Traces - Yes / (L) Front Fender - Repair Traces - Yes / (R) Rear Fender - Repair Traces - Yes / (R) Rear Door - Repair Traces - Yes / Member (Bolted) - Dent - Yes / Front Windshield - Damaged - Large / Front Bumper, Grille, Lamps - Scratch & Dent - Large / Bonnet, Headlight - Scratch & Dent - Medium / (L) Front Fender, Molding - Crack, Gap - Medium / (R) Front Fender, Molding - Repair mark - Yes / (R) Rear Door, Molding - Repair mark - Yes / (R) Rear Fender, Molding - Repair mark - Yes / (R) Front Door, Molding - Scratch & Dent - Small / (R) Rear Door, Molding - Scratch & Dent - Medium / Roof - Dent - Small / (R) Rear Fender, Molding - Scratch - Small / Trunk Hood, Rear Gate - Scratch - Small / Rear Bumper, Lamps, Panels - Scratch & Dent - Medium / (L) Rear Fender, Molding - Scratch - Small / (L) Step, In-panel, Side Spoiler - Scratch - Medium / (L) Rear Door, Molding - Scratch - Medium / (L) Front Door, Molding - Scratch & Dent - Small / (L) Mirror - Scratch - Minimal / (R) Front Fender, Molding - Scratch - Minimal |
