## General Information

| Make | Toyota | Model | Hiace |
| Registration No. | NEM5179 | Chassis No. | JTFJT02P5M5027992 |

## Body / Panel Condition

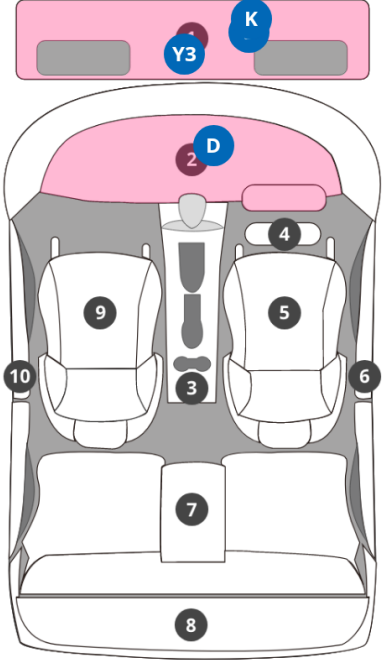
| Interior Evaluation : <b>B</b> | Exterior Evaluation : <b>E</b> |
|---|---|
| <p><b>Remarks</b><br/>Overall Interior - Smell - Yes / Overall Interior - Animal Hair - Yes / Dashboard - Traces of Adhesive Tape - Yes / Ceiling - Grime - Medium</p> | <p><b>Remarks</b><br/>(L) Front Door - Repair Traces - Yes / (L) Rear Fender, Molding - Scratch &amp; Dent - Small / (L) Rear Door, Molding - Scratch - Small / (L) Front Door, Molding - Scratch - Small / Front Bumper, Grille, Lamps - Crack, Gap - Medium / (R) Rear Fender, Molding - Scratch &amp; Dent - Large / Rear Bumper, Lamps, Panels - Scratch &amp; Dent - Small / Trunk Hood, Rear Gate - Scratch &amp; Dent - Small / (R) Rear Door, Molding - Scratch - Large / (R) Step, In-panel, Side Spoiler - Scratch &amp; Dent - Large / Bonnet, Headlight - Repair mark - Yes / (R) Front Door, Molding - Scratch &amp; Dent - Small / Roof - Scratch - Small / (R) Rear Wheel, Cover - Cap Missing - Yes / (L) Rear Wheel, Cover - Cap Missing - Yes</p> |
