## General Information

| Make | Toyota | Model | Wigo |
| Registration No. | NEL5051 | Chassis No. | MHKA4DF5FMJ057389 |

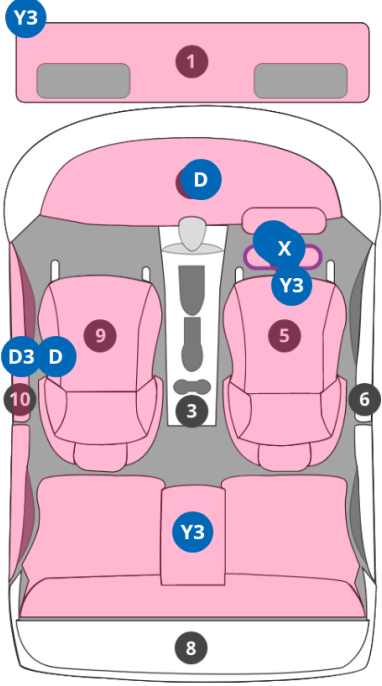
| Interior Evaluation : <span style="color: red;">C</span> | Exterior Evaluation : <span style="color: red;">C</span> |
| <p><b>Remarks</b></p> <p>Overall Interior - Worn as per age - Yes / Mat Other - Missing - Yes / (R) Front Floor Mat - Missing - Yes / (L) Front Floor Mat - Missing - Yes / (R) Front Seat - Grime - Medium / (L) Front Seat - Worn - Yes / Rear Seat - Grime - Medium / (L) Front Trim - Loose, Deformed - Medium / Ceiling - Grime - Medium / Dashboard - Traces of Adhesive Tape - Yes</p> | <p><b>Remarks</b></p> <p>(R) Front Fender - Repair Traces - Yes / Bonnet - Repair Traces - Yes / (L) Front Fender - Repair Traces - Yes / (L) Front Door - Repair Traces - Yes / (R) Rear Door - Repair Traces - Yes / Roof - Repair Traces - Yes / (R) Mirror - Scratch - Small / (R) Front Fender, Molding - Scratch - Minimal / (R) Front Door, Molding - Scratch &amp; Dent - Minimal / (R) Rear Door, Molding - Scratch &amp; Dent - Small / (R) Rear Fender, Molding - Scratch &amp; Dent - Minimal / Rear Bumper, Lamps, Panels - Crack, Gap - Medium / Trunk Hood, Rear Gate - Scratch &amp; Dent - Minimal / (L) Rear Fender, Molding - Scratch - Small / (L) Step, In-panel, Side Spoiler - Scratch - Small / (L) Rear Door, Molding - Scratch - Minimal / (L) Front Door, Molding - Scratch - Small / (L) Mirror - Scratch - Minimal / (L) Front Fender, Molding - Scratch - Minimal / Front Bumper, Grille, Lamps - Scratch &amp; Dent - Medium / Bonnet, Headlight - Scratch - Minimal / Roof - Scratch - Small</p> |
