## General Information

| Make | Toyota | Model | Vios |
| YOM | 2021 | Odo Meter Reading | 59,651 |
| Registration No. | NEM1829 | Chassis No. | PA1B18F39M4144753 |

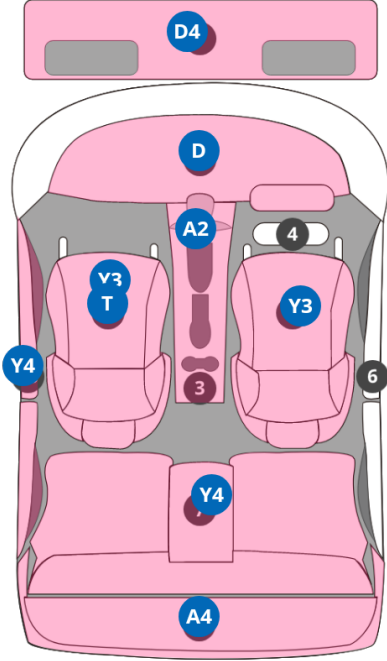
| Interior Evaluation : <b>E</b> | Exterior Evaluation : <b>E</b> |
| <p><b>Remarks</b></p> <p>Trunk Room - Worn, Scratch, Cut, Crack - Large / Rear Seat - Grime - Large / Ceiling - Crinkle - Large / (R) Front Seat - Grime - Medium / (L) Front Trim - Grime - Large / (L) Front Seat - Grime - Medium / Dashboard - Traces of Adhesive Tape - Yes / Console, Switches, Vents - Worn, Scratch, Cut, Crack - Small / (L) Front Seat - Cigarette Burns - Burnt, Hole</p> | <p><b>Remarks</b></p> <p>(R) Step - Repair Traces - Yes / (R) Front Fender - Repair Traces - Yes / Bonnet - Repair Traces - Yes / (L) Front Fender - Repair Traces - Yes / (R) Rear Door - Repair Traces - Yes / Bonnet, Headlight - Repair mark - Yes / (R) Front Fender, Molding - Repair mark - Yes / (L) Front Fender, Molding - Repair mark - Yes / Front Bumper, Grille, Lamps - Repair mark - Yes / (R) Rear Door, Molding - Repair mark - Yes / (R) Front Fender, Molding - Scratch &amp; Dent - Small / (R) Front Door, Molding - Scratch &amp; Dent - Large / (R) Mirror - Scratch - Small / (R) Rear Door, Molding - Scratch &amp; Dent - Large / (R) Step, In-panel, Side Spoiler - Scratch - Large / (R) Rear Fender, Molding - Scratch - Medium / Rear Bumper, Lamps, Panels - Repair mark - Yes / Rear Bumper, Lamps, Panels - Scratch - Large / Trunk Hood, Rear Gate - Scratch &amp; Dent - Large / (L) Rear Fender, Molding - Repair mark - Yes / (L) Rear Fender, Molding - Scratch &amp; Dent - Small / (L) Rear Door, Molding - Scratch &amp; Dent - Large / (L) Rear Door, Molding - Repair mark - Yes / (L) Front Door, Molding - Scratch &amp; Dent - Large / (L) Step, In-panel, Side Spoiler - Dent - Medium / (L) Front Fender, Molding - Scratch - Small / Front Bumper, Grille, Lamps - Scratch - Medium / Bonnet, Headlight - Crack, Gap - Large / Roof - Scratch - Medium</p> |
