## General Information

<b>Make</b>	Toyota	<b>Model</b>	Fortuner
<b>YOM</b>	2024	<b>Odo Meter Reading</b>	30,064
<b>Registration No.</b>	DBF5902	<b>Chassis No.</b>	MHFCB3GS6P0495044
<b>CC</b>	2.4	<b>Transmission</b>	A/T
<b>Fuel Type</b>	Diesel	<b>Type of Body</b>	SUV
<b>Colour</b>	Silver

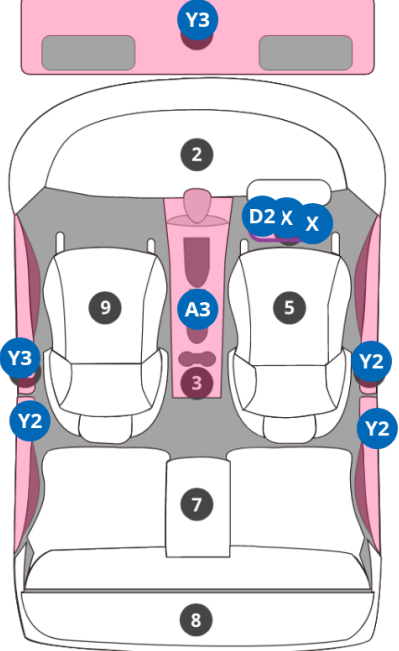
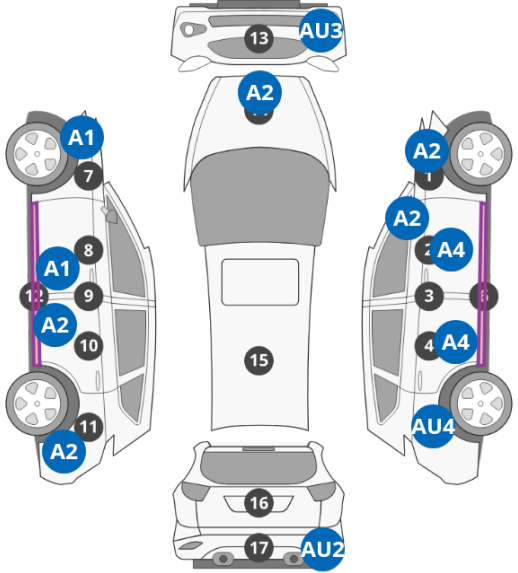
<b>Interior Evaluation :</b>	C	<b>Exterior Evaluation :</b>	E

<p><b>a</b> : Cut, Fray <b>d</b> : Loose, Deformed <b>k</b> : Animal Hair <b>s</b> : Smell <b>t</b> : Cigarette Burns <b>x</b> : Defective <b>y</b> : Stain</p>		<p><b>A</b> : Scratch <b>AU</b> : Scratch &amp; Dent <b>B</b> : Modified <b>C</b> : Corrosion <b>G</b> : Stone chip <b>P</b> : Faded <b>S</b> : Rust <b>SC</b> : Rust &amp; Corrosion <b>U</b> : Dent <b>X</b> : Defective <b>Y</b> : Crack, Gap</p>	
<p><b>Remarks</b> Ceiling - Grime - Medium / (R) Front Trim - Grime - Small / (R) Front Floor Mat - Missing - Yes / Mat Other - Missing - Yes / (L) Rear Trim - Grime - Small / (R) Rear Trim - Grime - Small / (L) Front Trim - Grime - Medium / (L) Front Floor Mat - Worked - Small / Knobs - Worn, Peel, Crack - Medium</p>		<p><b>Remarks</b> (L) Step, In-panel, Side Spoiler - Partially Missing - Yes / (R) Step, In-panel, Side Spoiler - Partially Missing - Yes / Front Bumper, Grille, Lamps - Scratch &amp; Dent - Medium / (R) Front Fender, Molding - Scratch - Small / (R) Mirror - Scratch - Small / (R) Front Door, Molding - Scratch - Large / (R) Rear Door, Molding - Scratch - Large / (R) Rear Fender, Molding - Scratch &amp; Dent - Large / Rear Bumper, Lamps, Panels - Scratch &amp; Dent - Small / (L) Rear Fender, Molding - Scratch - Small / (L) Rear Door, Molding - Scratch - Small / (L) Front Door, Molding - Scratch - Minimal / (L) Front Fender, Molding - Scratch - Minimal / Bonnet, Headlight - Scratch - Small</p>
