## General Information

| Make | Toyota | Model | Vios |
| Registration No. | NEY5380 | Chassis No. | PA1B18F3XR4261782 |

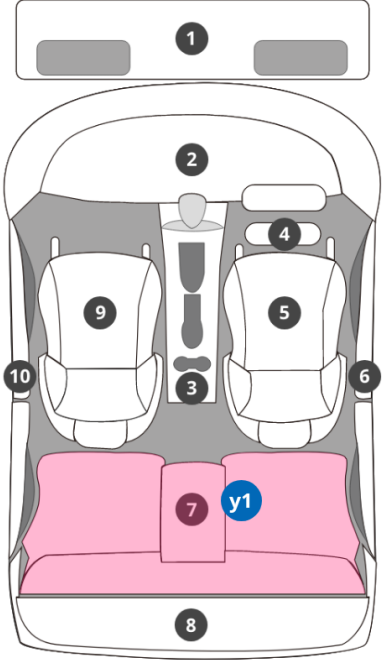
| Interior Evaluation : <b>A</b> | Exterior Evaluation : <b>C</b> |
| <b>Remarks</b><br>Rear Seat - Grime - Minimal | <b>Remarks</b><br>(L) Front Door, Molding - Scratch - Small / (L) Rear Door, Molding - Scratch - Medium / (L) Rear Fender, Molding - Scratch - Small / Rear Bumper, Lamps, Panels - Scratch - Small / (R) Rear Door, Molding - Scratch - Small / (R) Front Door, Molding - Scratch - Medium / Bonnet, Headlight - Scratch - Small / Roof - Scratch - Medium |

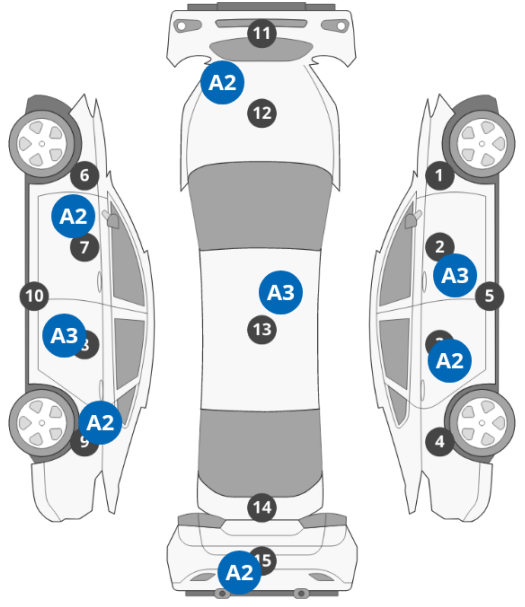
| Inspector Notes |
|---|
| swirlmarks and hairline scratches around the exterior. |
