## General Information

| Make | Toyota | Model | Vios |
| Registration No. | NIH6820 | Chassis No. | PA1B18F36P4209815 |

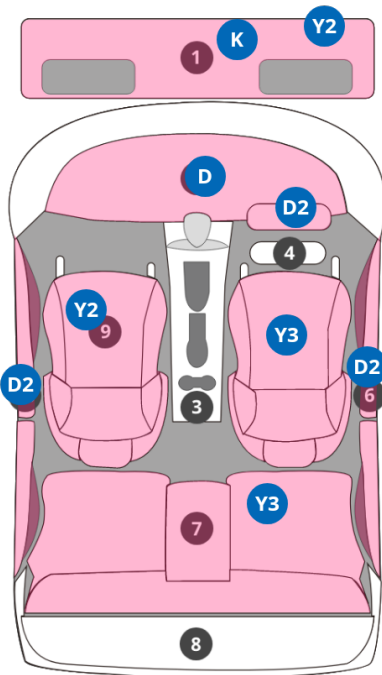
| Interior Evaluation : <b>C</b> | Exterior Evaluation : <b>E</b> |
| <p><b>Remarks</b></p> <p>Overall Interior - Animal Hair - Yes / Ceiling - Grime - Small / (R) Front Seat - Grime - Medium / Rear Seat - Grime - Medium / (L) Front Seat - Grime - Small / Glove Box - Loose, Deformed - Small / Dashboard - Traces of Adhesive Tape - Yes / (L) Front Trim - Worked - Small / (R) Front Trim - Worked - Small</p> | <p><b>Remarks</b></p> <p>(R) Front Door - Repair Traces - Yes / (R) Front Fender - Repair Traces - Yes / Bonnet - Repair Traces - Yes / (R) Front Fender, Molding - Scratch &amp; Dent - Large / (R) Front Door, Molding - Repair mark - Yes / Bonnet, Headlight - Repair mark - Yes / (R) Front Fender, Molding - Repair mark - Yes / Front Bumper, Grille, Lamps - Crack, Gap - Large / Member (Bolted) - Dent - Yes / (R) Step, In-panel, Side Spoiler - Dent - Minimal / (R) Front Door, Molding - Scratch - Small / (R) Rear Door, Molding - Scratch - Small / (R) Rear Fender, Molding - Scratch - Minimal / Rear Bumper, Lamps, Panels - Scratch - Medium / Trunk Hood, Rear Gate - Scratch - Minimal / (L) Rear Fender, Molding - Scratch - Small / (L) Rear Door, Molding - Scratch - Small / (L) Front Door, Molding - Scratch - Minimal / (L) Front Fender, Molding - Scratch &amp; Dent - Small / Bonnet, Headlight - Modified - Medium / Roof - Scratch &amp; Dent - Small</p> |
