## General Information

| Make | Toyota | Model | Vios |
| YOM | 2024 | Odo Meter Reading | 5,563 |
| Registration No. | NKD6467 | Chassis No. | PA1B18F38R4257973 |

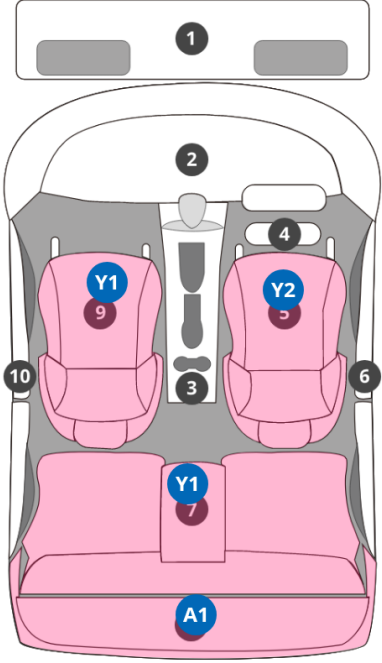
| <b>Remarks</b><br>Trunk Room - Worn, Scratch, Cut, Crack - Minimal /<br>Rear Seat - Grime - Minimal / (R) Front Seat - Grime - Small / (L) Front Seat - Grime - Minimal | <b>Remarks</b><br>Bonnet - Repair Traces - Yes / (L) Front Fender - Repair Traces - Yes / (L) Front Door - Repair Traces - Yes / (L) Step - Repair Traces - Yes / (L) Rear Door - Repair Traces - Yes / (L) Front Door, Molding - Repair mark - Yes / Bonnet, Headlight - Repair mark - Yes / Front Bumper, Grille, Lamps - Repair mark - Yes / (L) Front Fender, Molding - Repair mark - Yes / (L) Rear Door, Molding - Repair mark - Yes / (R) Front Fender, Molding - Scratch - Small / (R) Front Door, Molding - Scratch - Small / (R) Rear Door, Molding - Scratch - Medium / (R) Mirror - Scratch - Minimal / Rear Bumper, Lamps, Panels - Scratch - Medium / Trunk Hood, Rear Gate - Scratch - Small / (L) Rear Fender, Molding - Scratch - Small / (L) Mirror - Crack - Damaged / Roof - Scratch - Medium / Overall Exterior - Re-Paint Uneven - Yes |
