General Information

Make	Honda	Model	HR-V
YOM	2021	Odo Meter Reading	59,247
Registration No.	JAL5295	Chassis No.	MRHU5890MP020120
CC	1.8	Transmission	A/T
Fuel Type	Gas	Type of Body	SUV
Colour	Orange

Body / Panel Condition

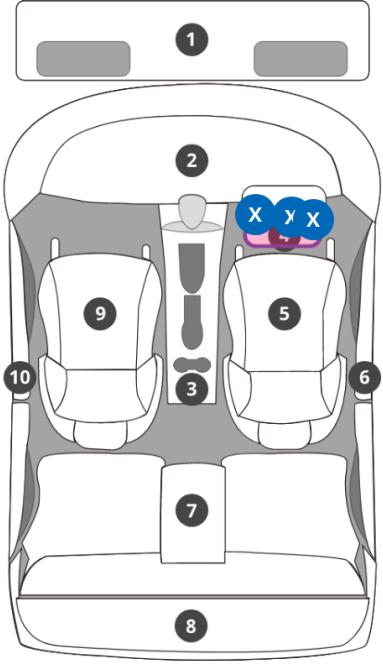
Interior Evaluation : B	Exterior Evaluation : E

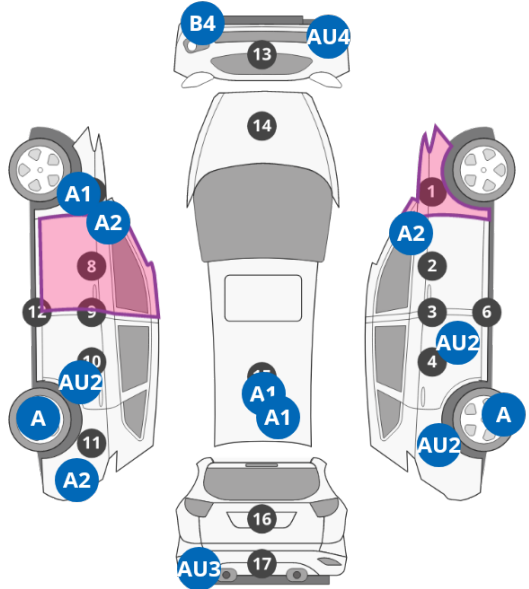
<p>A : Scratch AU : Scratch & Dent B : Modified C : Corrosion G : Stone chip P : Faded S : Rust SC : Rust & Corrosion U : Dent X : Defective Y : Crack, Gap</p>
Remarks (R) Front Floor Mat - Missing - Yes / (L) Front Floor Mat - Missing - Yes / Mat Other - Missing - Yes	Remarks (R) Front Door - Repair Traces - Yes / (R) Front Fender - Repair Traces - Yes / (L) Front Door - Repair Traces - Yes / (R) Mirror - Scratch - Small / (R) Rear Door, Molding - Scratch & Dent - Small / (R) Rear Fender, Molding - Scratch & Dent - Small / (R) Rear Tyre - Crack, Cut - Yes / Rear Bumper, Lamps, Panels - Scratch & Dent - Medium / (R) Front Fender, Molding - Repair mark - Yes / Front Bumper, Grille, Lamps - Modified - Large / (L) Mirror - Scratch - Small / (L) Front Door, Molding - Repair mark - Yes / (L) Rear Door, Molding - Scratch & Dent - Small / (L) Rear Fender, Molding - Scratch - Small / (L) Front Fender, Molding - Scratch - Minimal / Roof - Scratch - Minimal / Roof Spoiler, Molding - Scratch - Minimal / (L) Rear Tyre - Crack, Cut - Yes / Front Bumper, Grille, Lamps - Scratch & Dent - Large

Inspector Notes
with lto plate, 1 key, with spare tire, no warranty booklet, no jack and tools, right front bumper repaired,
