## General Information

Date & Time: 21, Jul, 2025 18:08

<b>Make</b>	Hino	<b>Model</b>	XZU710LN
<b>YOM</b>	2024	<b>Odo Meter Reading</b>	26,982
<b>Registration No.</b>	NKF3932	<b>Chassis No.</b>	JHHUCP3F2RK056263
<b>CC</b>	4.0	<b>Transmission</b>	M/T
<b>Fuel Type</b>	Diesel	<b>Type of Body</b>	Aluminum Van
<b>Colour</b>	White

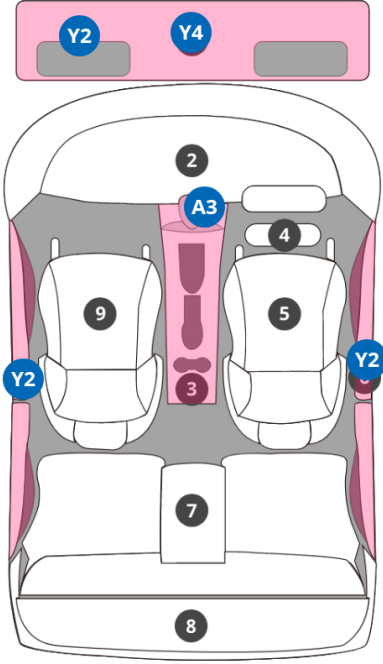
<b>Interior Evaluation :</b> <span style="float: right; color: red; font-weight: bold;">C</span>	<b>Exterior Evaluation :</b> <span style="float: right; color: red; font-weight: bold;">C</span>

<p><b>a</b> : Cut, Fray <b>d</b> : Loose, Deformed <b>k</b> : Animal Hair <b>s</b> : Smell <b>t</b> : Cigarette Burns <b>x</b> : Defective <b>y</b> : Stain</p>

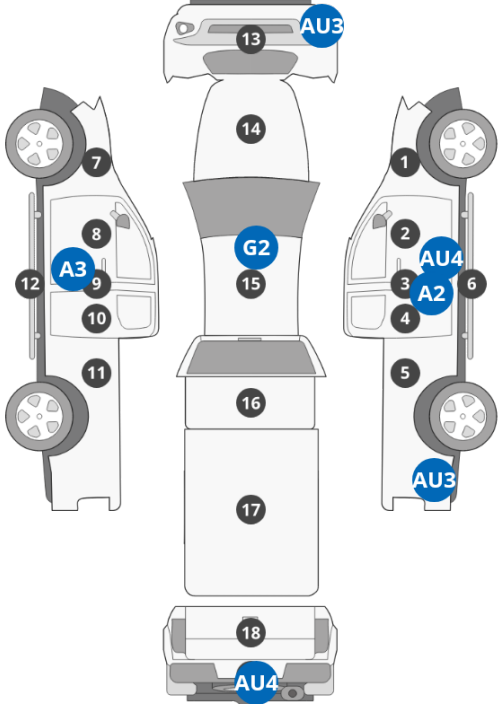
<p><b>A</b> : Scratch <b>AU</b> : Scratch &amp; Dent <b>B</b> : Modified <b>C</b> : Corrosion <b>G</b> : Stone chip <b>P</b> : Faded <b>S</b> : Rust <b>SC</b> : Rust &amp; Corrosion <b>U</b> : Dent <b>X</b> : Defective <b>Y</b> : Crack, Gap</p>
<p><b>Remarks</b> Ceiling - Grime - Large / Sunvisor, Sunglass Holder - Grime - Small / (R) Front Trim - Grime - Small / (L) Front Trim - Grime - Small / Console, Switchs, Vents - Worn, Scratch, Cut, Crack - Medium</p>	<p><b>Remarks</b> (L) Front Door, Molding - Scratch - Medium / (R) Front Door, Molding - Scratch &amp; Dent - Large / (R) Rear Corner Panel - Scratch - Small / (R) Side Gate - Scratch &amp; Dent - Medium / Rear Bumper, Lamps, Panels - Scratch &amp; Dent - Large / Front Bumper, Grille, Lamps - Scratch &amp; Dent - Medium / Front Windshield - Scratch, Stone chip - Small</p>
