## General Information

<b>Make</b>	Toyota	<b>Model</b>	Vios
<b>YOM</b>	2022	<b>Odo Meter Reading</b>	65,219
<b>Registration No.</b>	NES9484	<b>Chassis No.</b>	PA1B18F3XM4164008
<b>CC</b>	1.3	<b>Transmission</b>	CVT
<b>Fuel Type</b>	Gas	<b>Type of Body</b>	Sedan
<b>Colour</b>	Blackish Red Mica

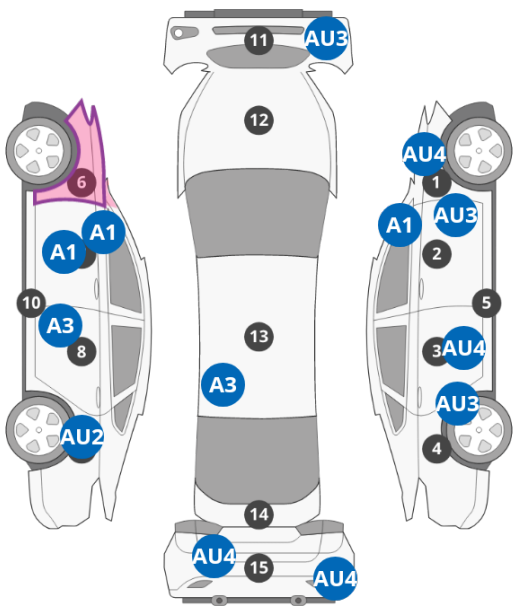
<p><b>A</b> : Scratch <b>AU</b> : Scratch &amp; Dent <b>B</b> : Modified <b>C</b> : Corrosion <b>G</b> : Stone chip <b>P</b> : Faded <b>S</b> : Rust <b>SC</b> : Rust &amp; Corrosion <b>U</b> : Dent <b>X</b> : Defective <b>Y</b> : Crack, Gap</p>
<p><b>Remarks</b> Sunvisor, Sunglass Holder - Grime - Medium / Ceiling - Grime - Small / (R) Front Trim - Grime - Small / (R) Front Floor Mat - Grime - Medium / (R) Front Seat - Grime - Medium / Mat Other - Grime - Medium / Rear Seat - Grime - Medium / (L) Front Trim - Grime - Medium / (L) Front Floor Mat - Cut, Crack - Medium / (L) Front Seat - Grime - Small</p>	<p><b>Remarks</b> (L) Rear Fender - Repair Traces - Yes / (R) Rear Door, Molding - Scratch &amp; Dent - Large / (R) Rear Fender, Molding - Scratch &amp; Dent - Medium / (R) Front Door, Molding - Scratch &amp; Dent - Medium / (R) Front Fender, Molding - Scratch &amp; Dent - Large / Front Bumper, Grille, Lamps - Scratch &amp; Dent - Medium / (R) Mirror - Scratch - Minimal / Trunk Hood, Rear Gate - Scratch &amp; Dent - Large / Rear Bumper, Lamps, Panels - Scratch &amp; Dent - Large / (L) Rear Fender, Molding - Scratch &amp; Dent - Small / (L) Rear Door, Molding - Scratch - Medium / (L) Mirror - Scratch - Minimal / (L) Front Door, Molding - Scratch - Minimal / (L) Front Fender, Molding - Repair mark - Yes / Roof - Scratch - Medium</p>
