General Information

| Make | Toyota | Model | Vios |
| YOM | 2022 | Odo Meter Reading | 59,920 |
| Registration No. | BAC3126 | Chassis No. | PA1B18F32M4165816 |

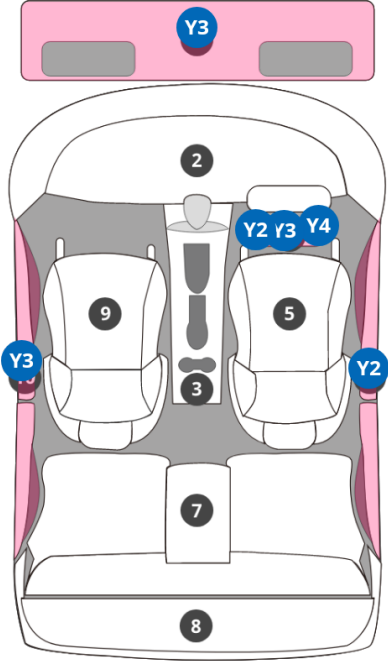
| <p>Remarks Ceiling - Grime - Medium / (R) Front Trim - Grime - Small / (R) Front Floor Mat - Grime - Large / Mat Other - Grime - Medium / (L) Front Trim - Grime - Medium / (L) Front Floor Mat - Grime - Small</p> | <p>Remarks Bonnet - Repair Traces - Yes / Rear Bumper, Lamps, Panels - Repair mark - Yes / Front Bumper, Grille, Lamps - Repair mark - Yes / Bonnet, Headlight - Repair mark - Yes / Overall Exterior - Re-Paint Uneven - Yes / Front Bumper, Grille, Lamps - Modified - Large / Front Bumper, Grille, Lamps - Scratch & Dent - Large / Bonnet, Headlight - Scratch - Small / (R) Mirror - Scratch - Small / (R) Front Fender, Molding - Scratch & Dent - Small / (R) Front Door, Molding - Scratch - Small / (R) Rear Door, Molding - Scratch - Small / (R) Rear Fender, Molding - Scratch & Dent - Small / Trunk Hood, Rear Gate - Scratch - Small / Rear Bumper, Lamps, Panels - Scratch & Dent - Large / (L) Rear Fender, Molding - Scratch - Small / (L) Rear Door, Molding - Scratch - Minimal / (L) Mirror - Crack - Cracks / (L) Front Fender, Molding - Scratch - Medium / Roof - Scratch - Small / (L) Front Door, Molding - Scratch & Dent - Small</p> |

| <p>Possible flooding. Muddy carpet. Without warranty booklet, jack and tools. With spare tire and leather seat cover. 1 key. With LTO plate.</p> |
