Date & Time: 25, Jul, 2025 08:30

<b>Make</b>	Toyota	<b>Model</b>	Innova
<b>YOM</b>	2017	<b>Odo Meter Reading</b>	111,978
<b>Registration No.</b>	AOA311	<b>Chassis No.</b>	PA2AA3EM9H0026025
<b>CC</b>	2.8	<b>Transmission</b>	A/T
<b>Fuel Type</b>	Diesel	<b>Type of Body</b>	Wagon
<b>Colour</b>	White

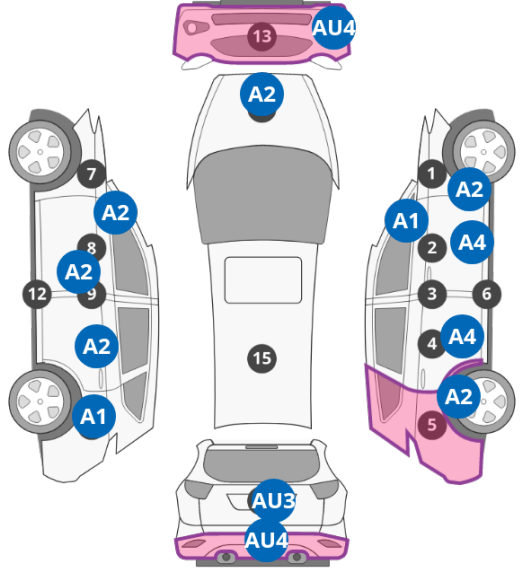
<p><b>A</b> : Scratch <b>AU</b> : Scratch &amp; Dent <b>B</b> : Modified <b>C</b> : Corrosion <b>G</b> : Stone chip <b>P</b> : Faded <b>S</b> : Rust <b>SC</b> : Rust &amp; Corrosion <b>U</b> : Dent <b>X</b> : Defective <b>Y</b> : Crack, Gap</p>
<p><b>Remarks</b> Ceiling - Grime - Large / (R) Front Trim - Grime - Medium / (R) Rear Trim - Grime - Small / (L) Rear Trim - Grime - Small / (L) Front Trim - Grime - Medium / (L) Front Floor Mat - Grime - Small</p>	<p><b>Remarks</b> Bonnet - Repair Traces - Yes / (L) Front Fender - Repair Traces - Yes / (L) Front Door - Repair Traces - Yes / Front Bumper, Grille, Lamps - Repair mark - Yes / Rear Bumper, Lamps, Panels - Repair mark - Yes / (L) Mirror - Scratch - Small / (L) Front Door, Molding - Scratch - Small / (L) Rear Door, Molding - Scratch - Small / (L) Rear Fender, Molding - Scratch - Minimal / Rear Bumper, Lamps, Panels - Scratch &amp; Dent - Large / Trunk Hood, Rear Gate - Scratch &amp; Dent - Medium / (R) Rear Fender, Molding - Repair mark - Yes / (R) Rear Door, Molding - Scratch - Large / (R) Front Door, Molding - Scratch - Large / (R) Rear Fender, Molding - Scratch - Small / (R) Mirror - Scratch - Minimal / (R) Front Fender, Molding - Scratch - Small / Bonnet, Headlight - Scratch - Small / Front Bumper, Grille, Lamps - Scratch &amp; Dent - Large</p>
